**Ref: ITB #2023-017B GRINDSTONE CANYON DAM CONCRETE REPAIR  
PRINCIPAL SPILLWAY AND NORTH DAM CREST**

**ADDENDUM #2**

**Subject: Grindstone Canyon Dam (OSE Filing No. D-513) Spillway and North Dam Crest  
Condition Assessment Report, Village of Ruidoso, New Mexico**

# **GRINDSTONE CANYON DAM (D-513) SPILLWAY AND NORTH DAM CREST CONDITION ASSESSMENT REPORT**

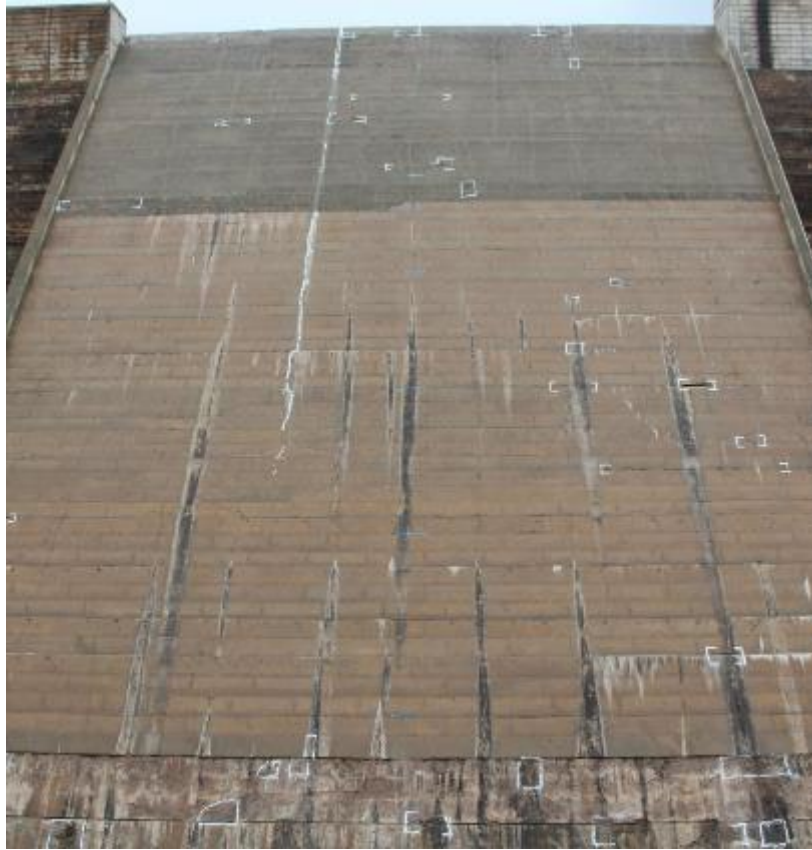
**Photo 2: Grindstone Canyon Dam Spillway (October 5, 2022)**

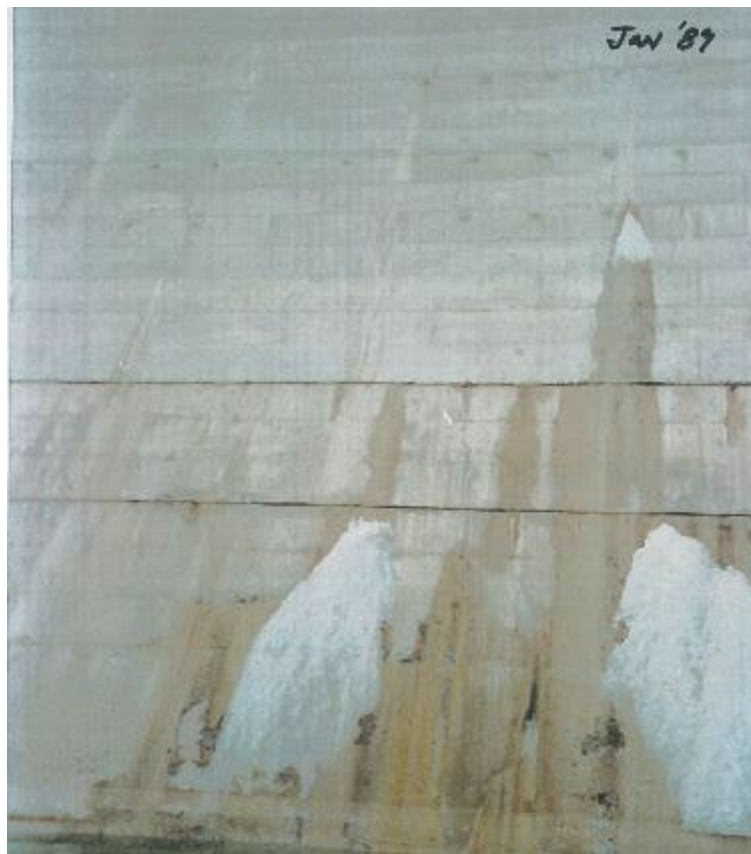
Extensive concrete erosion up to 2.5 inches deep was observed along the horizontal joint between the facing elements at the bottom of the spillway, just above the stilling basin pool. The welded wire fabric reinforcement in the facing elements is exposed in at least three locations along this joint. Drummy concrete also was identified in several areas below this joint. This erosion was likely due to seepage through the joint and freeze-thaw damage immediately following construction and filling of the reservoir. A January 1989 photograph shows extensive seepage and formation of ice on this lower part of the spillway (see Photo 3).

**Photo 3: January 1989 Photo of Lower Right Spillway Surface**

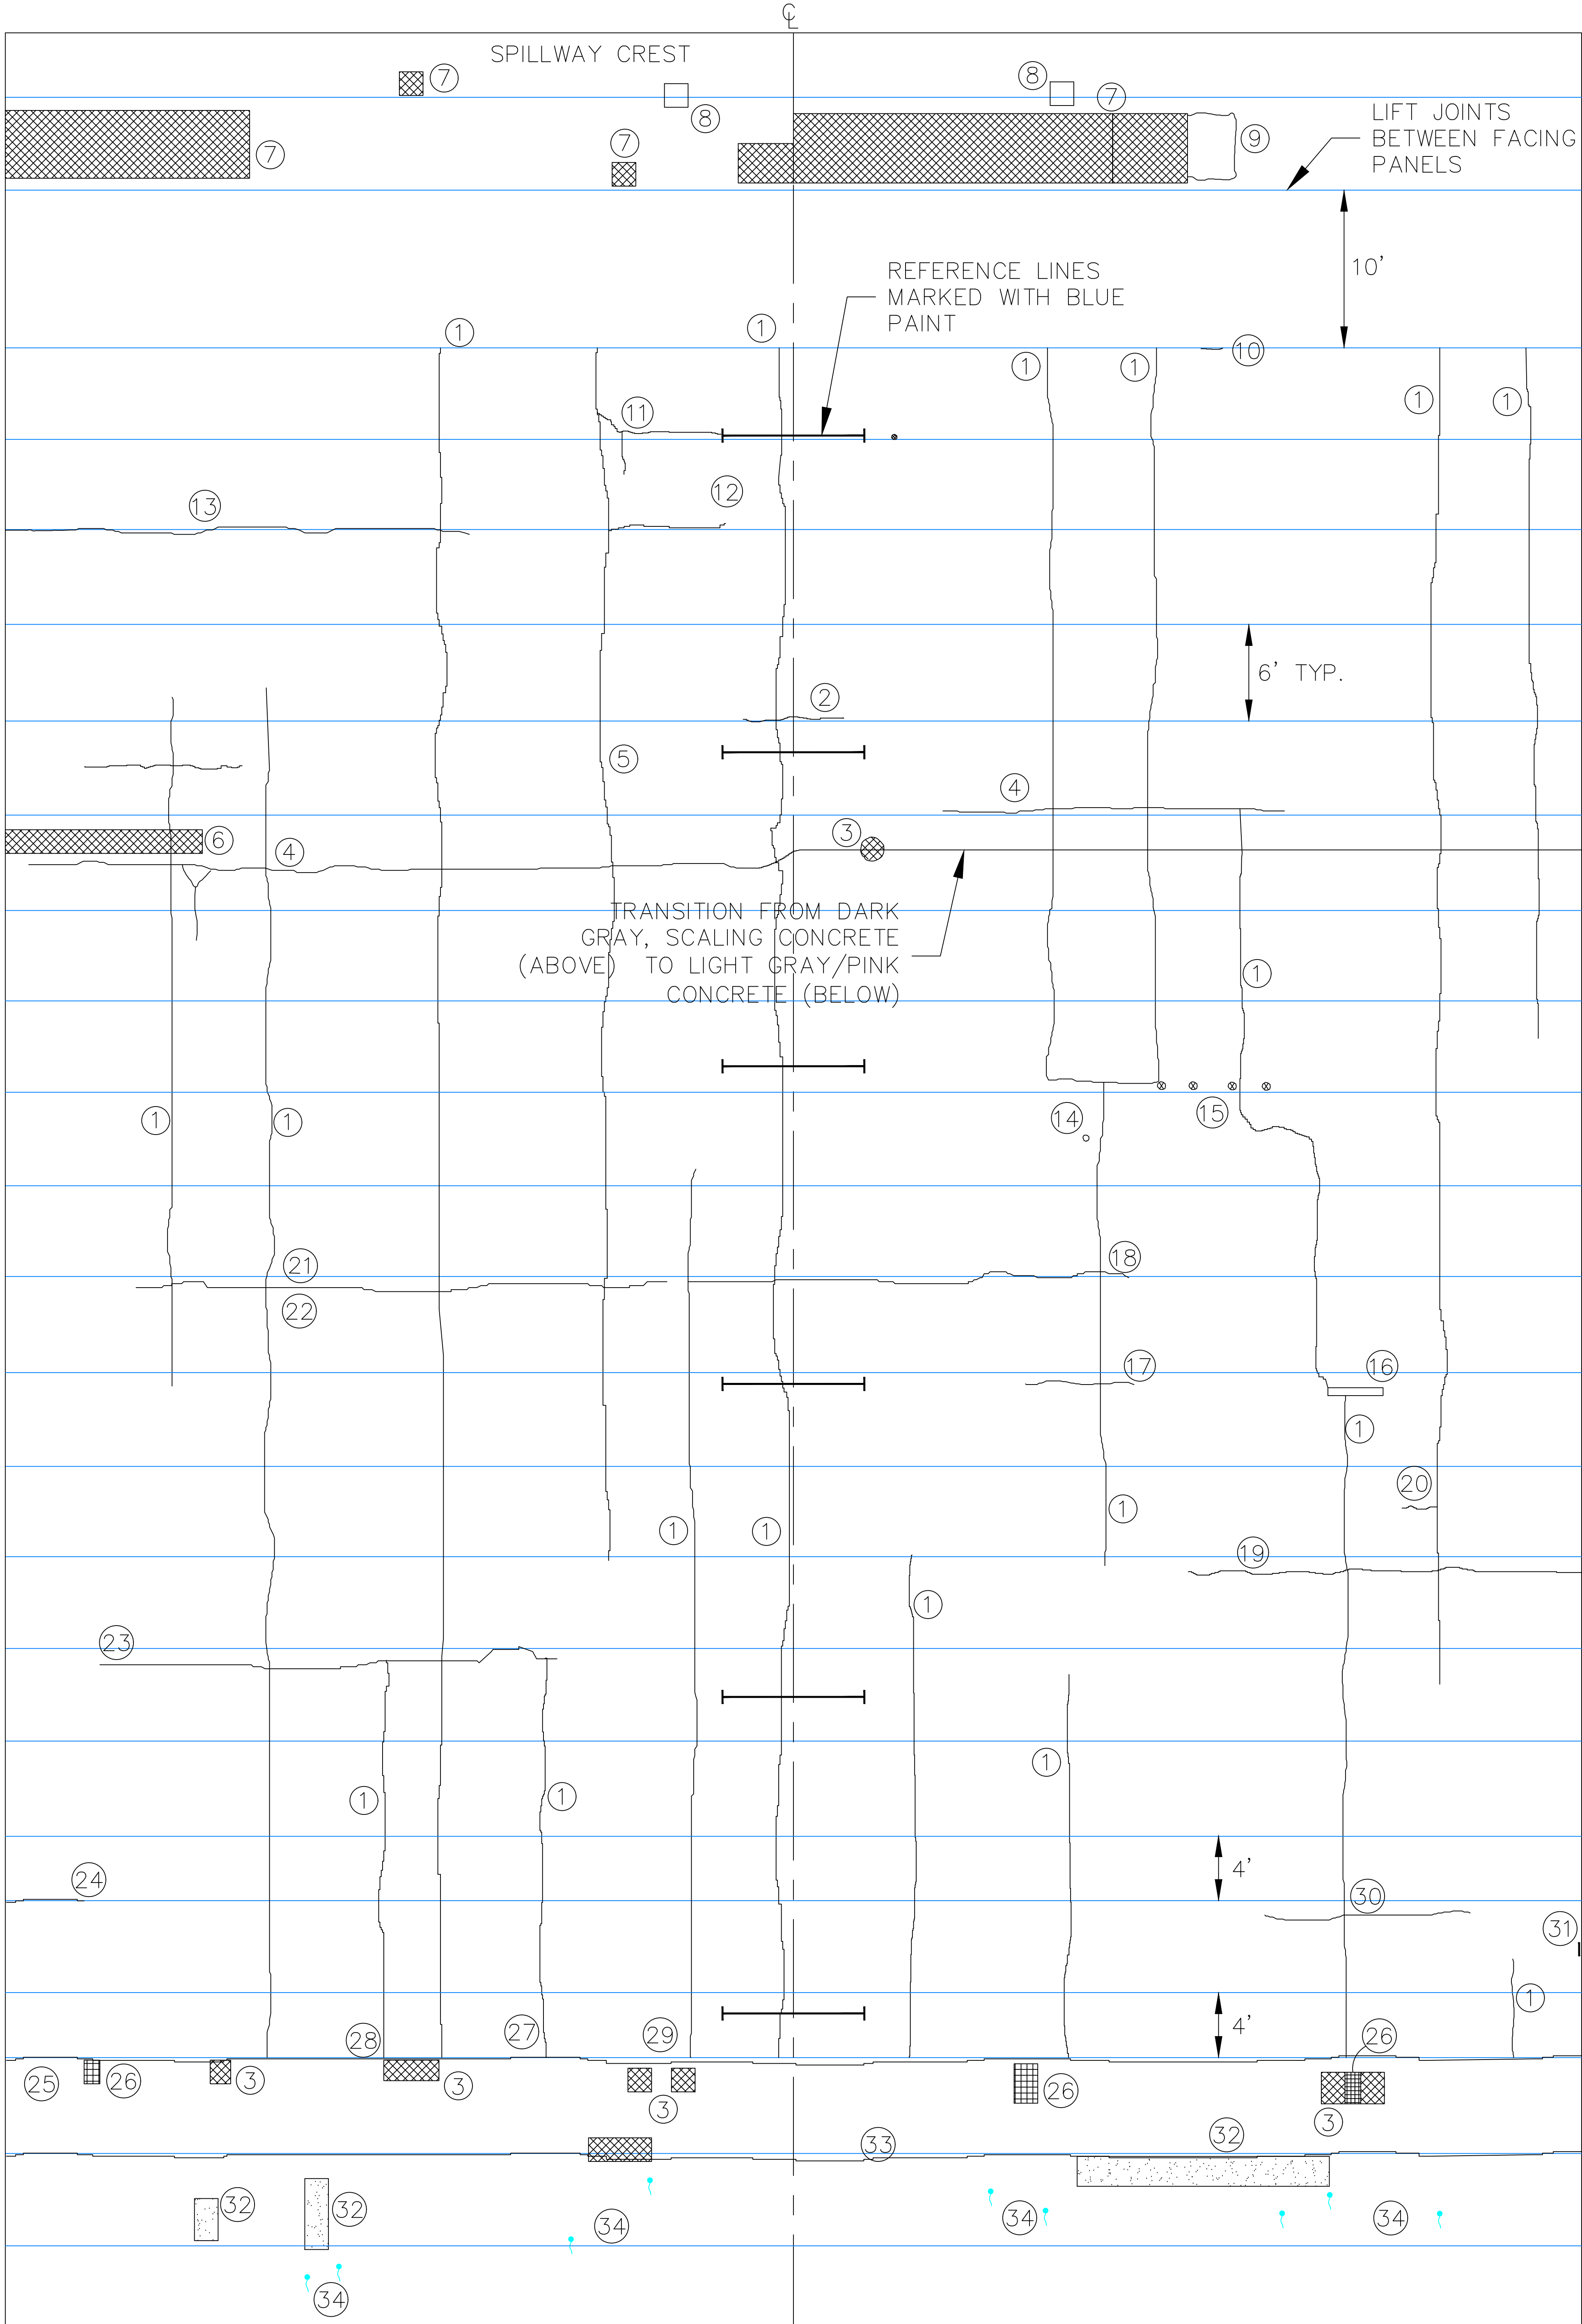
1. Cracks on surface; width varies; up to  $\sim 1/8$ " wide; appear to terminate at bottom of mass concrete.
2. Horizontal crack in surface, width varies, up to  $\sim 1/2$ " wide ; up to  $\sim 1$ : deep; needs repair.

3. Drummy area; up to  $\sim 1/2$ " deep.
4. Horizontal crack; width varies up to  $\sim 2$ "; depth up to 1.5"; needs repair.
5. Vertical crack; width varies; appears to have been previously repaired w/ surface caulk.

6. Drummy area; up to  $\sim 1$ " deep; needs repair;  $\sim 2'$  tall x  $\sim 12'$  wide.
7. Drummy area; up to  $\sim 1$ " deep; previously (and poorly) repaired.

8. Apparent cuts in concrete;  $\sim 18$ " tall x 8" wide; up to  $\sim 1$ " deep.
9. Spalling; up to  $\sim 3/4$ " deep.
10. Spalling at joint; up to  $\sim 2$ " wide; up to  $\sim 1$ " deep; appears to be transverse joint for mass concrete; needs repair.

11. Spalling at joint or crack; up to  $\sim 2$ " wide; up to  $\sim 1$ " deep; needs repair.
12. Spalling at joint; up to  $\sim 3$ " wide; up to  $\sim 2.5$ " deep; needs repair.

13. Open joint; some spalling; up to 2" wide; up to  $\sim 1$ " deep; may need repair.
14. Surface void in concrete;  $\sim 2$ " x 2"; up to 1" deep; may need repair.

15. Steel form ties; rusted; spalling up to 1.5" deep; four locations  $\sim 3$ " center-to-center; may need repair.
16. Rotted lumber embedded in spillway surface; needs repair.

17. Poor consolidation at joint; voids up to  $\sim 1/2$ " deep; may need repair.
18. Intersection of vertical crack & horizontal joint; up to  $\sim 1/2$ " deep; may need repair.

19. Horizontal joint with exposed aggregate & possibly rusted steel; voids up to  $\sim 1$ " deep; likely needs repair.
20. Spalling at horizontal crack or joint; up to  $\sim 1.5$ " wide; up to  $\sim 3/4$ " deep; width varies; likely needs repair.

21. Horizontal joint; poor consolidation; voids up to  $1/2$ " deep; voids vary in length; may need repair.
22. Exposed rebar;  $\sim 11$ " exposed; oriented horizontally parallel to surface; may need repair.

23. Poor consolidation along horizontal joint; up to  $\sim 1$ " wide; up to  $\sim 3/4$ " deep; may need repair.
24. Poor consolidation along horizontal joint (rock pocket); up to 1" deep; may need repair.

25. Transition from relatively good concrete to deteriorated concrete (freeze-thaw damage); up to 2.5" offset between surfaces; formwork lines visible on deteriorated concrete original surface; drummy area  $\sim 2$ 'x $12$ " located  $\sim 3'$  from right training wall; aggregate up to  $\sim 1$ "; needs repair.

26. Exposed welded wire mesh;  $\sim 2.5$ " to 4" below apparent original surface; needs repair.
27. Exposed rebar at surface;  $\sim 1$ "x $1$ " void around bar; may need repair.

28. Spalling along vertical crack; up to  $\sim 4$ " wide;  $\sim 7$ " tall; up to  $\sim 1/2$ " deep; may need repair.
29. Spalling along vertical crack; up to  $\sim 2$ " wide; up to  $\sim 1/2$ " deep; may need repair.

30. Spalling along horizontal joint; intersection with vertical crack; up to 4" wide; up to ~1" deep; may need repair.
31. Thin (<1/8") concrete layer; likely from formwork above leaking during construction.
32. Eroded concrete areas (from freeze-thaw); up to 8" wide; up to ~1.5" deep; spalling concrete; needs repair.
33. Eroded concrete along horizontal joint; up to ~6" wide; up to ~1.5" deep; needs repair.
34. Active seeps at horizontal joint; Brent (VOR) notes flow appears to increase in winter; possibly due to concrete contraction; needs to be considered for repair.

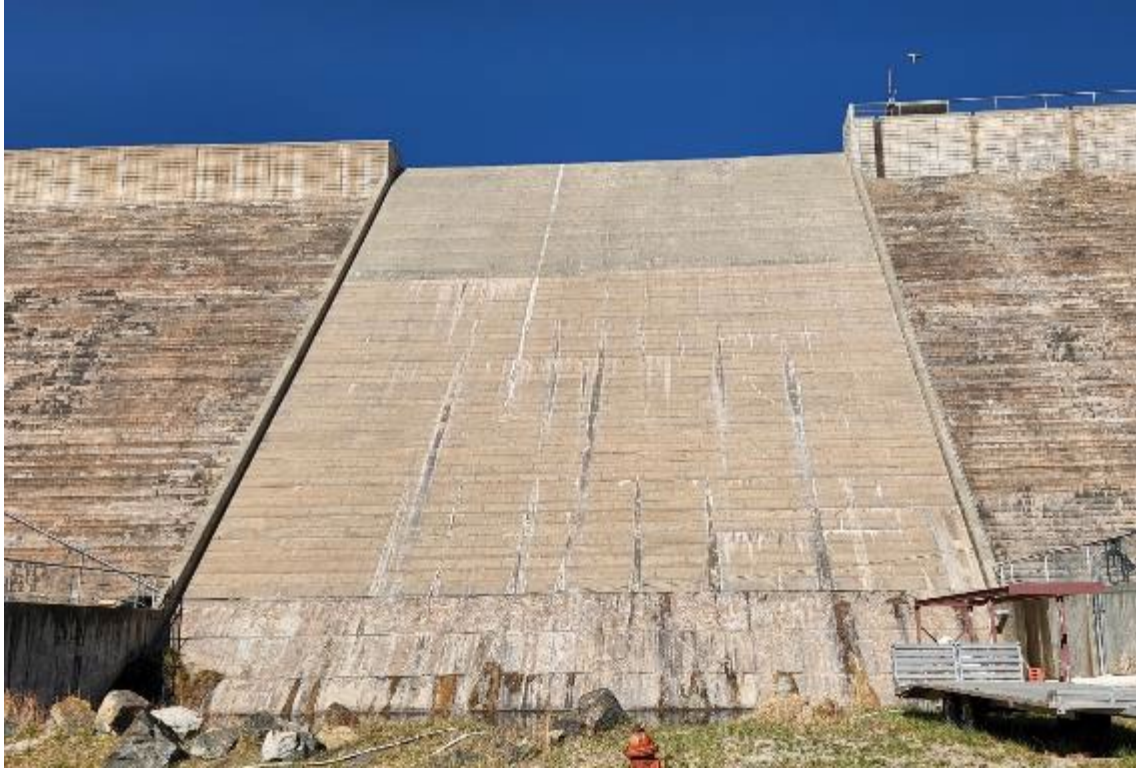
**Photo 4: Emergency spillway**

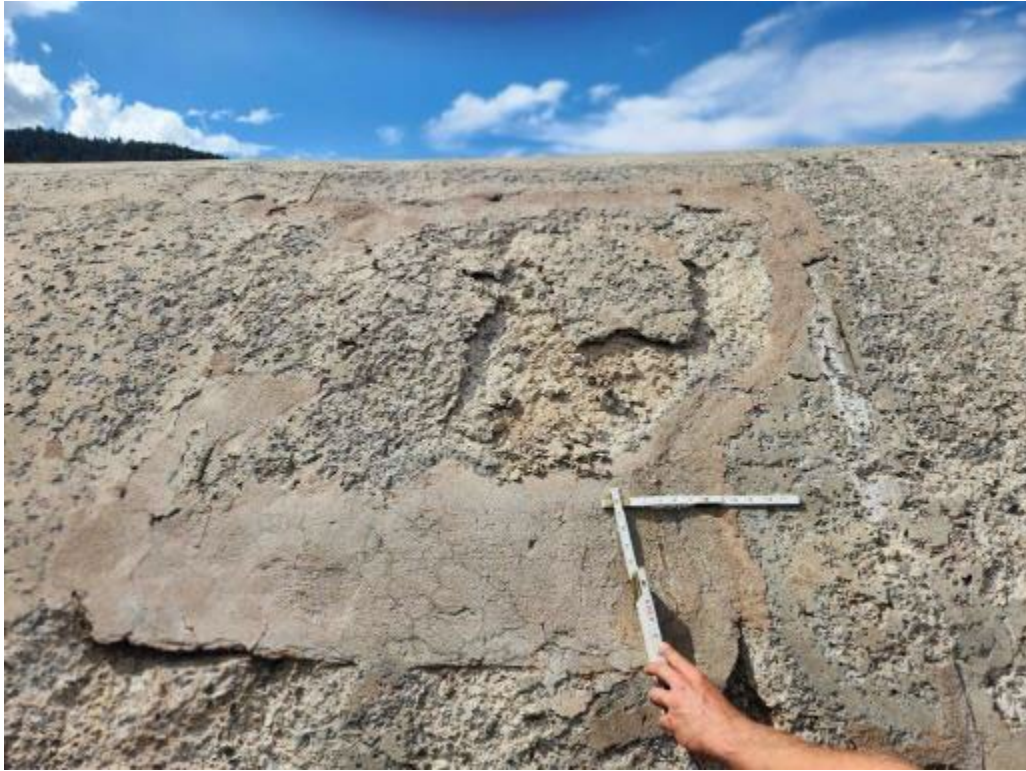
**Photo 5: Dam crest drummy concrete surface delamination**

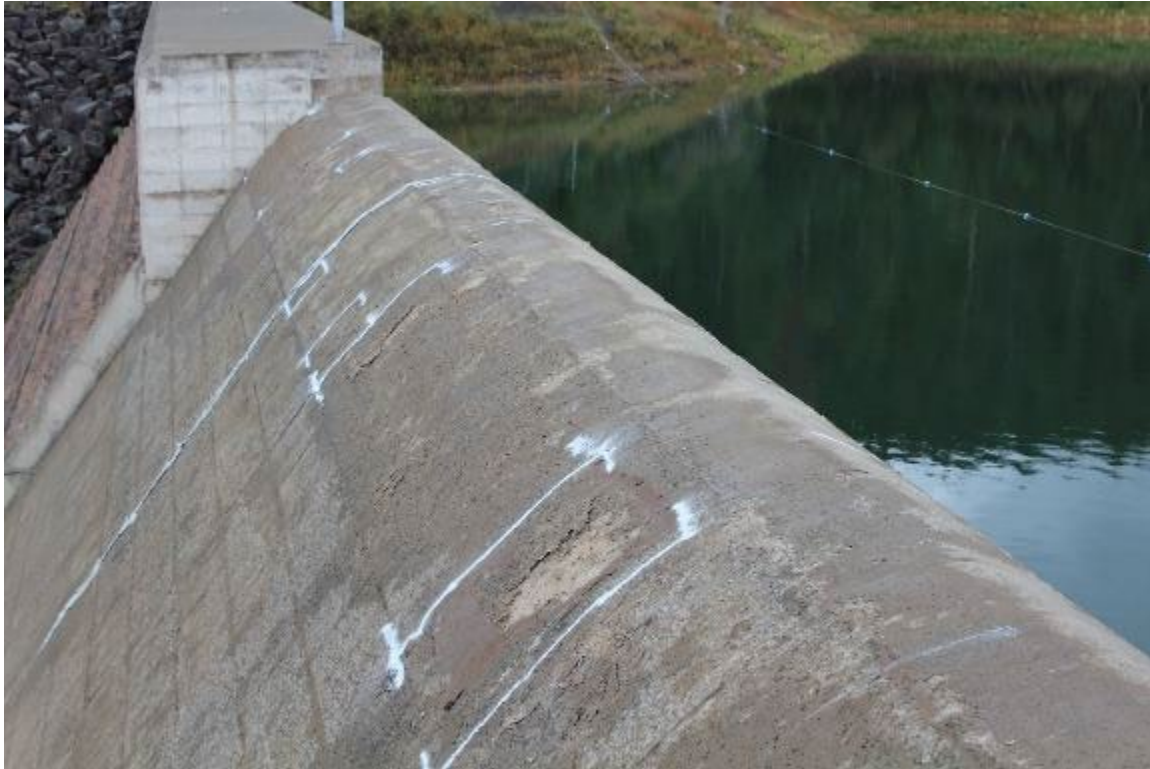
**Photo 6: Delaminated areas on spillway crest**

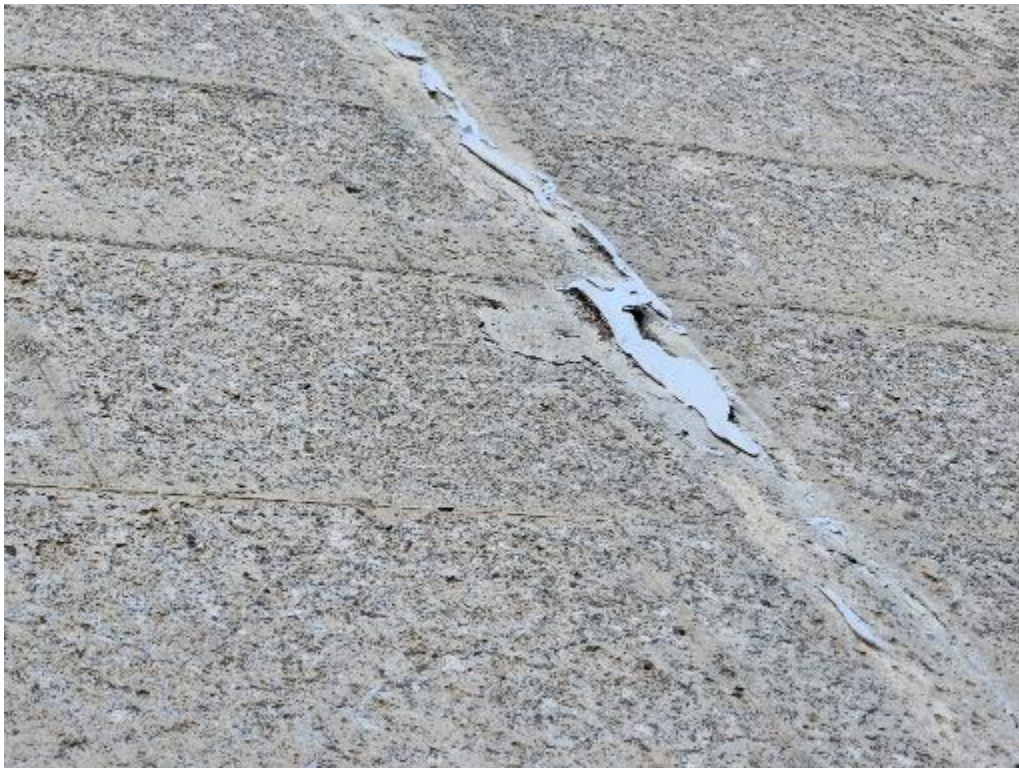
The sealant smeared on the vertical crack on the downstream face of the spillway in December 1989 has failed and is peeling off of the concrete. It appears this crack was not prepared properly prior to installation of the sealant.

**Photo 7: Failed crack repair (Field Note 5)**

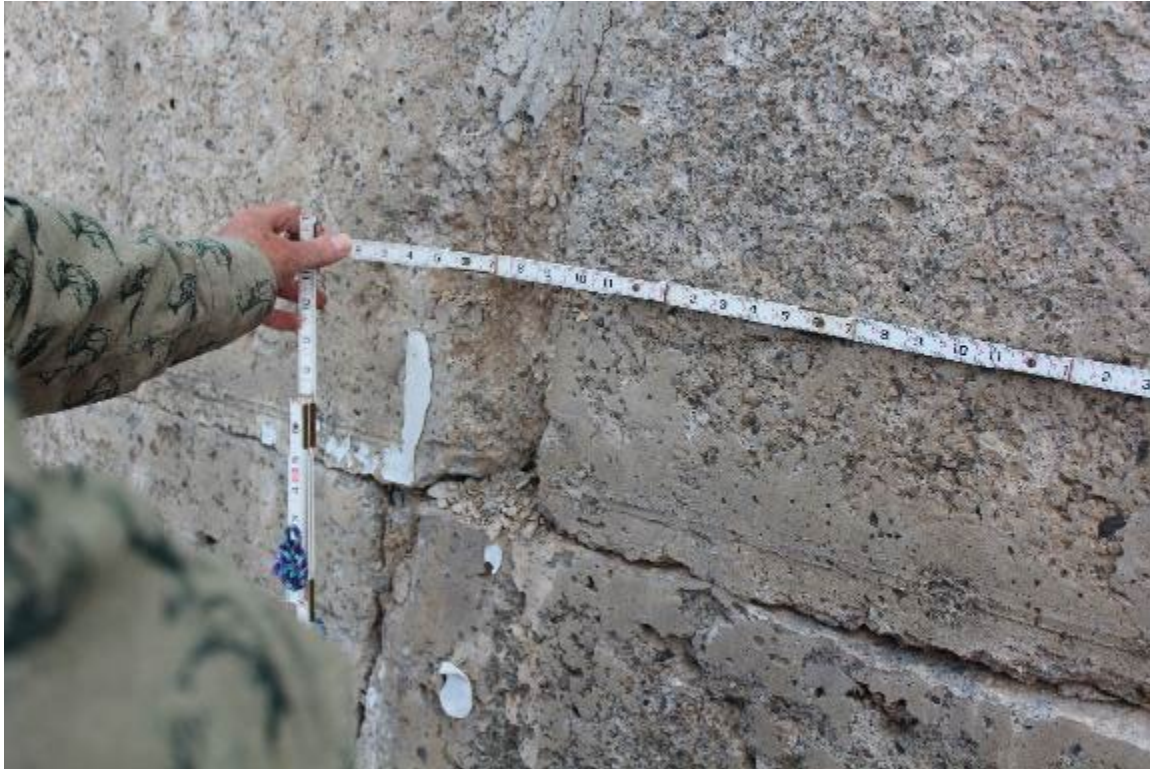
**Photo 8: Spalling at vertical crack on spillway**

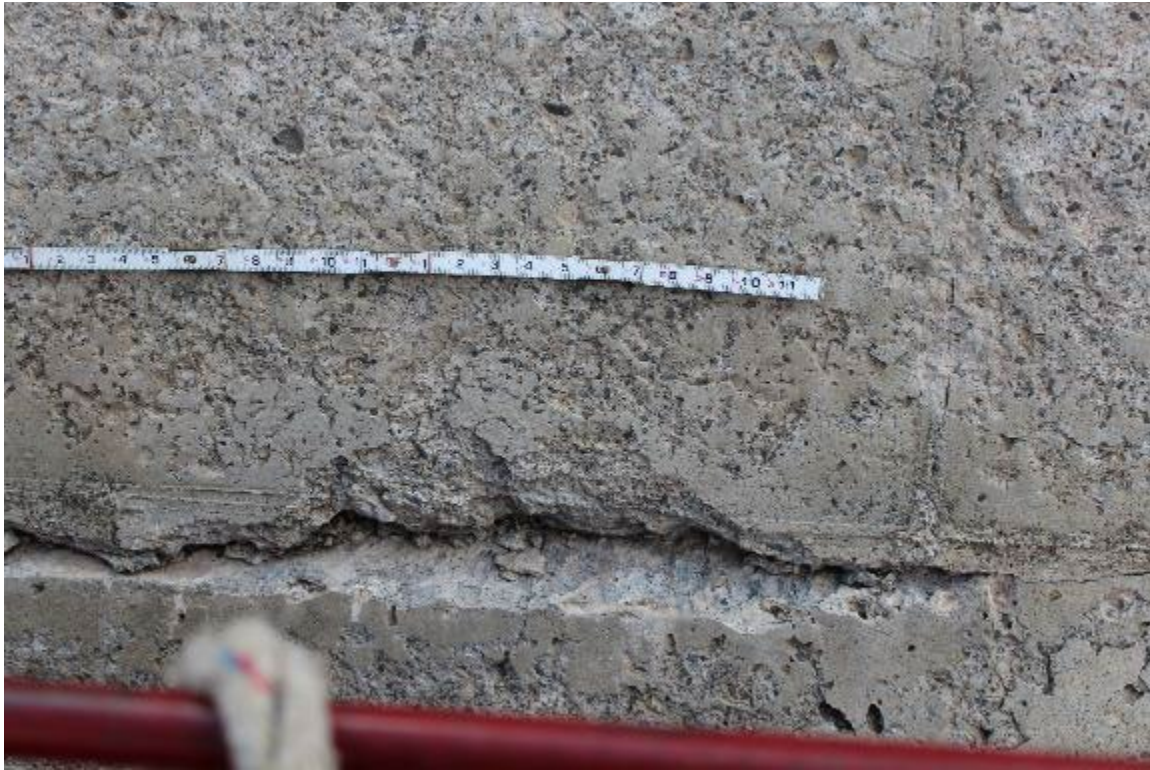
**Photo 9: Spalling at horizontal joint on spillway**

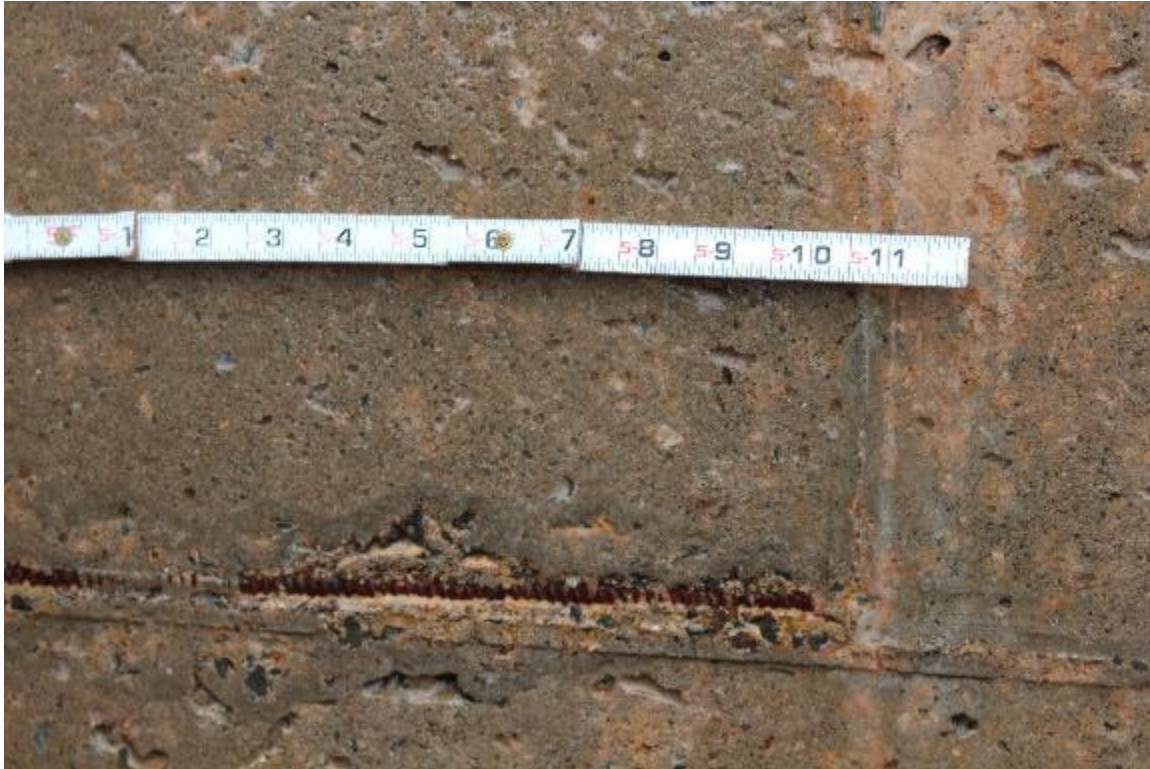
**Photo 10: Rebar exposed on spillway concrete surface (Field Note 22)**

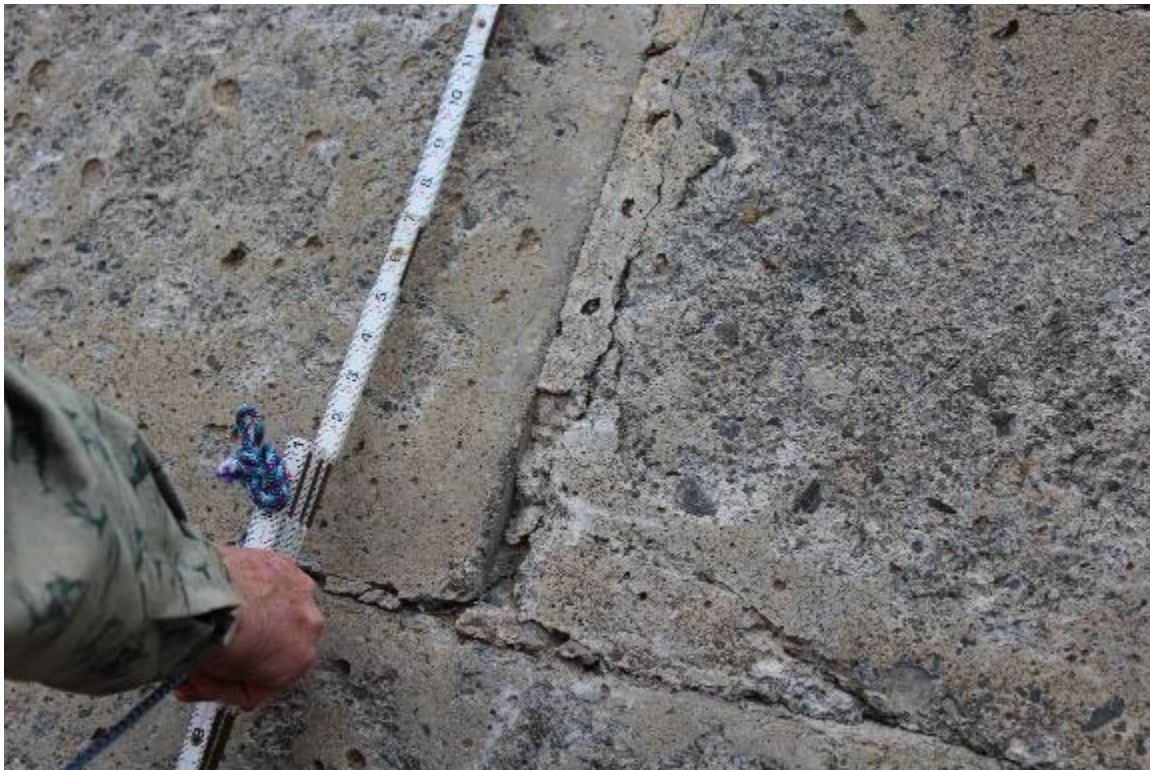
**Photo 11: Deterioration and spalling at vertical joint on spillway surface.**

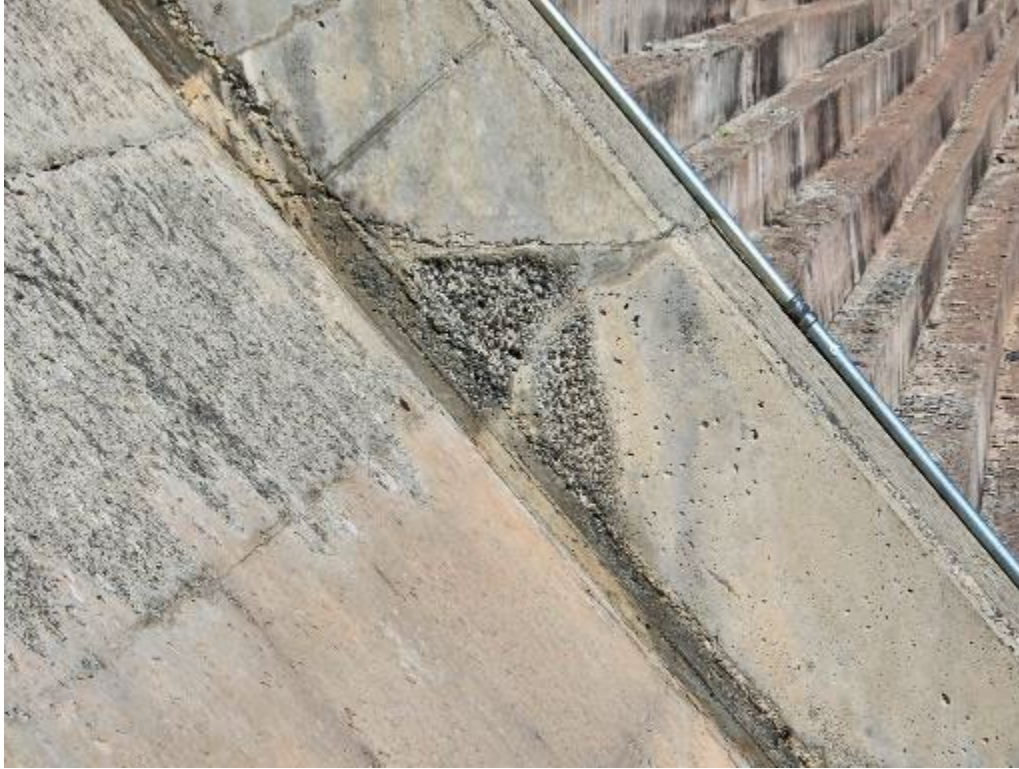
**Photo 12: Poor consolidation and cracking on spillway left training wall**

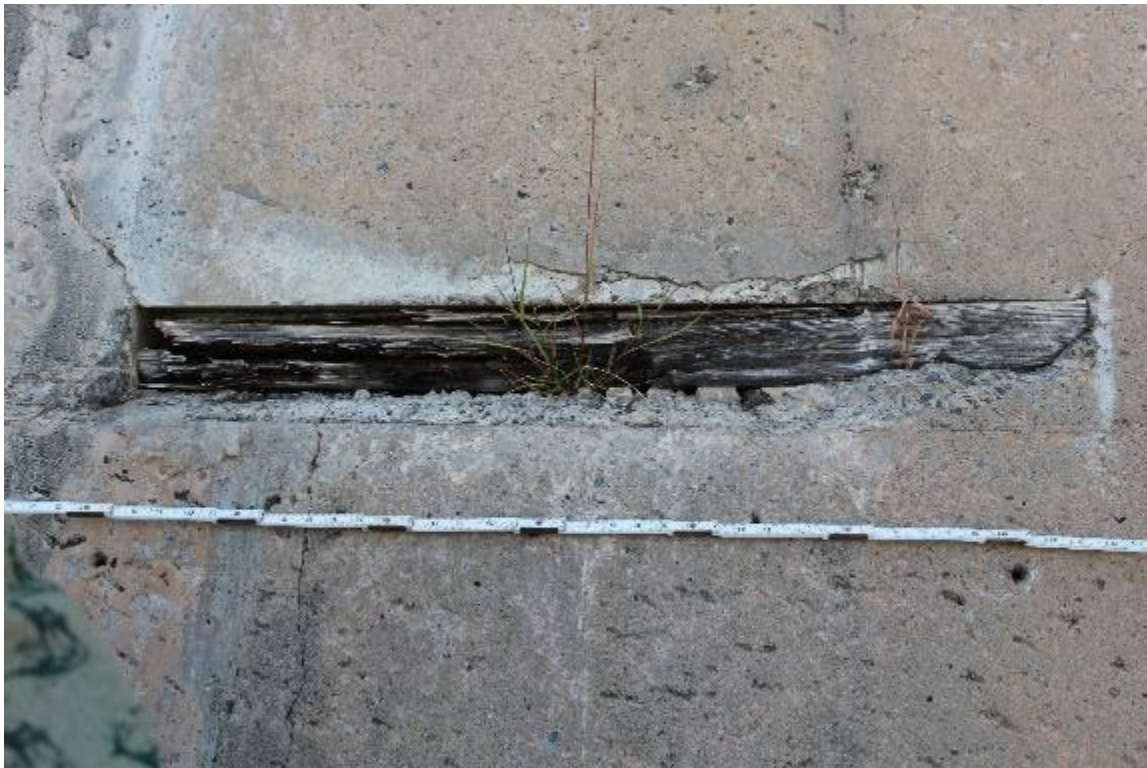
An approximately 4-inch by 3-foot piece of lumber was observed embedded in the concrete surface near the left side of the spillway about one-third of the distance from the bottom of the spillway (see note 16 on Plate 1). Previous observations during routine inspections indicated this was an exposed rebar. A photograph of the piece of lumber is included in Appendix B.

**Photo 13: Wood embedded in concrete surface**

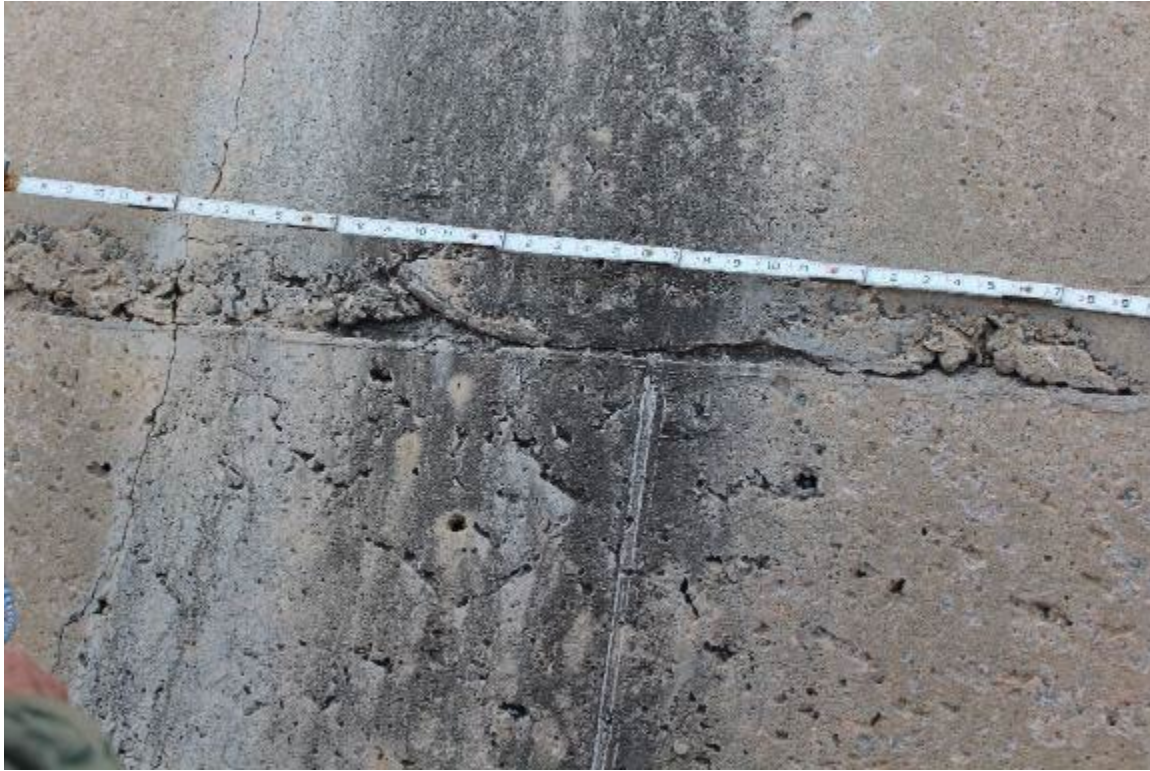
**Photo 14: Poor consolidation at horizontal joint between facing panels**

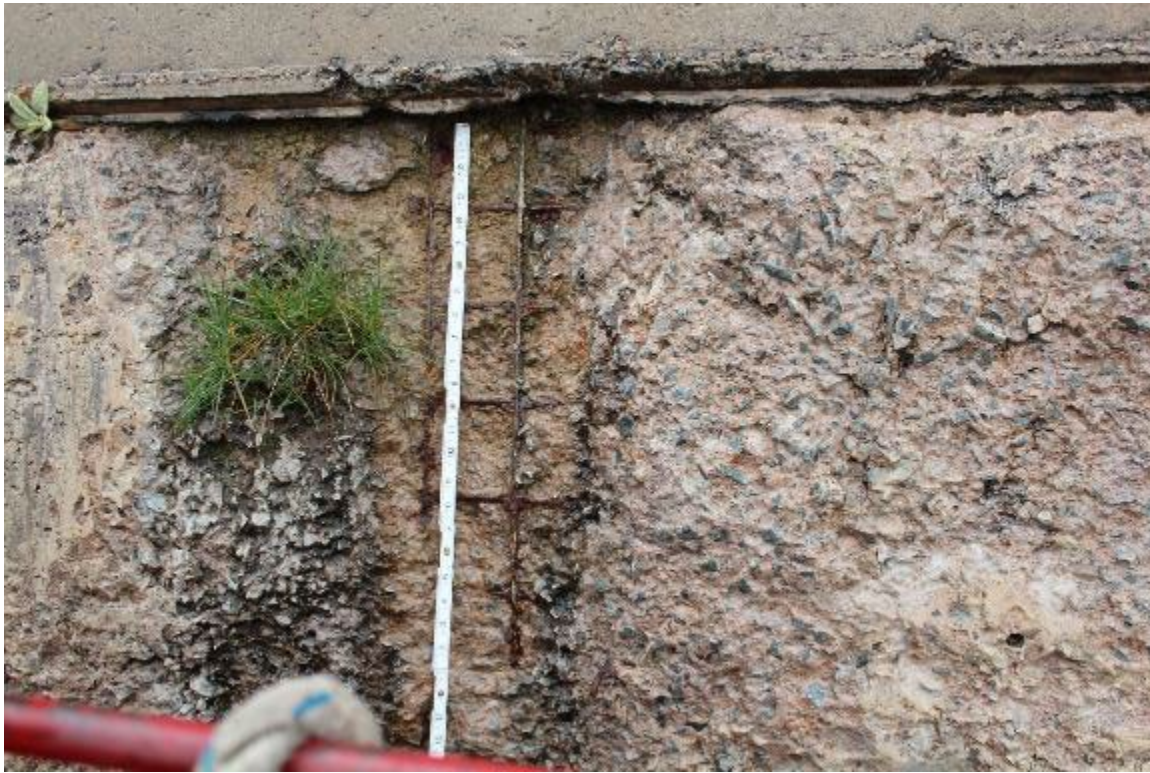
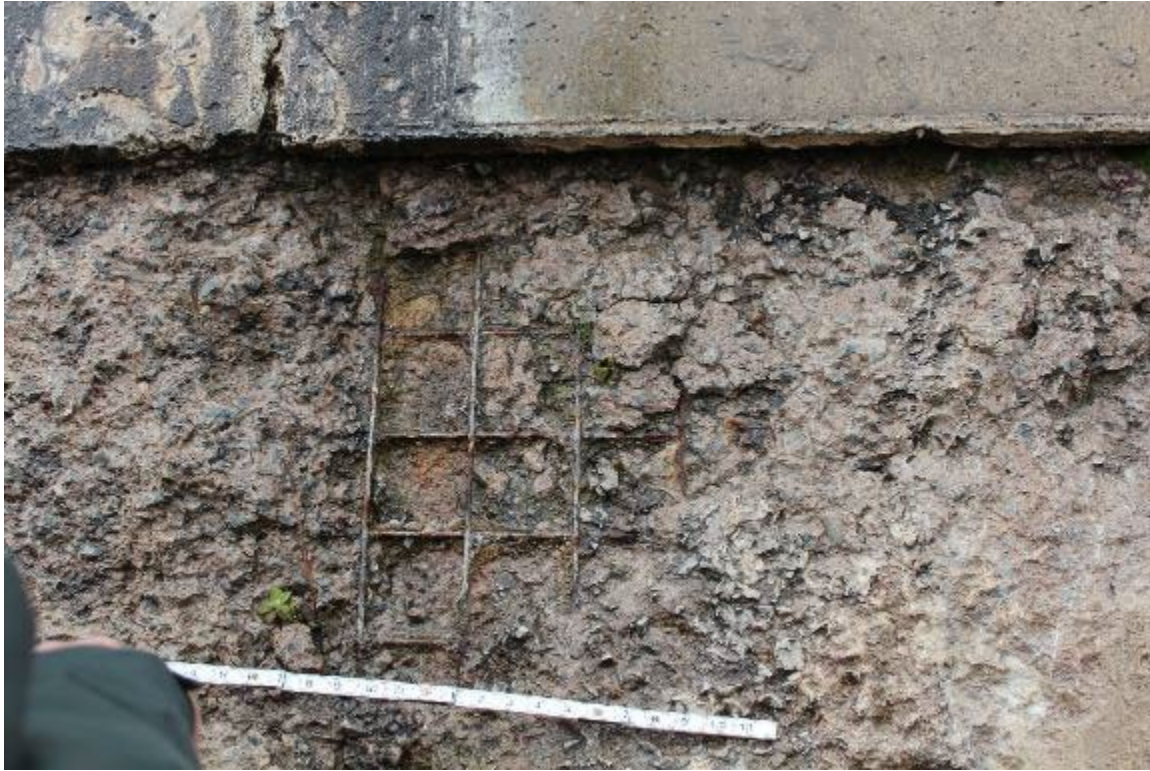
**Photo 15: Exposed welded wire fabric at top of third facing element above bottom of spillway**

**Photo 16: Exposed welded wire fabric at top of third facing element above bottom of spillway**

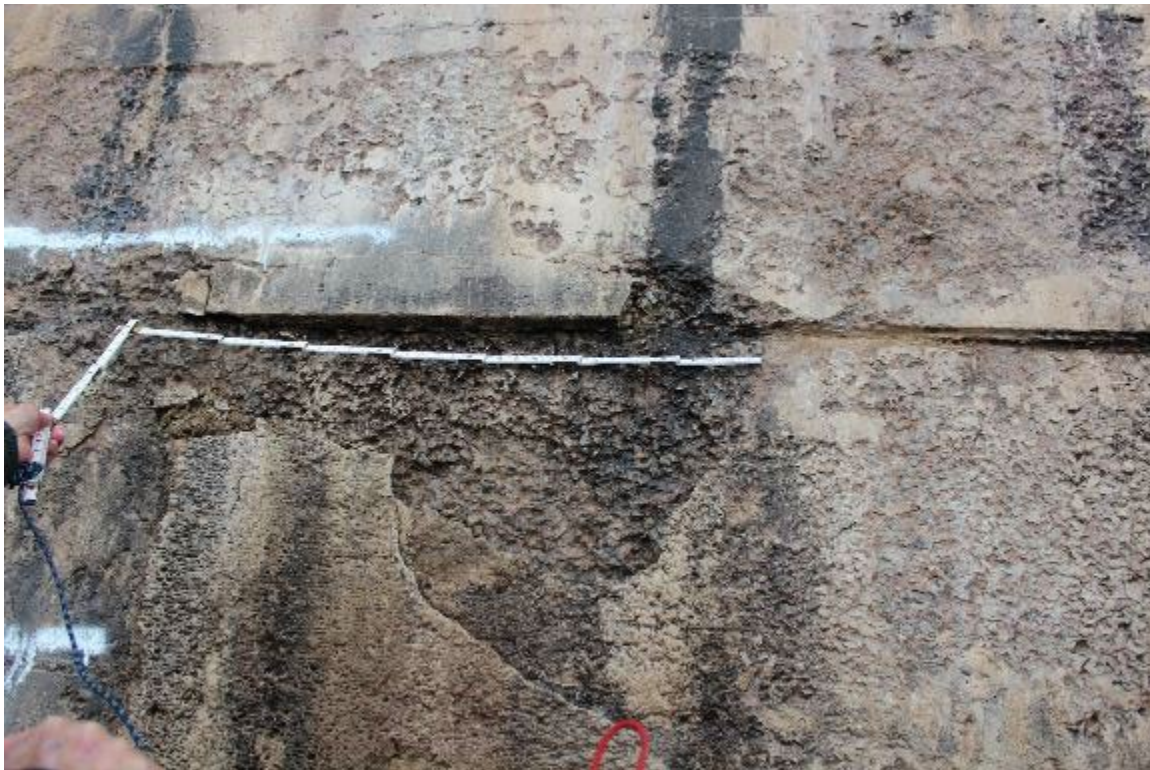
**Photo 17: Erosion on concrete surface on lower facing elements**

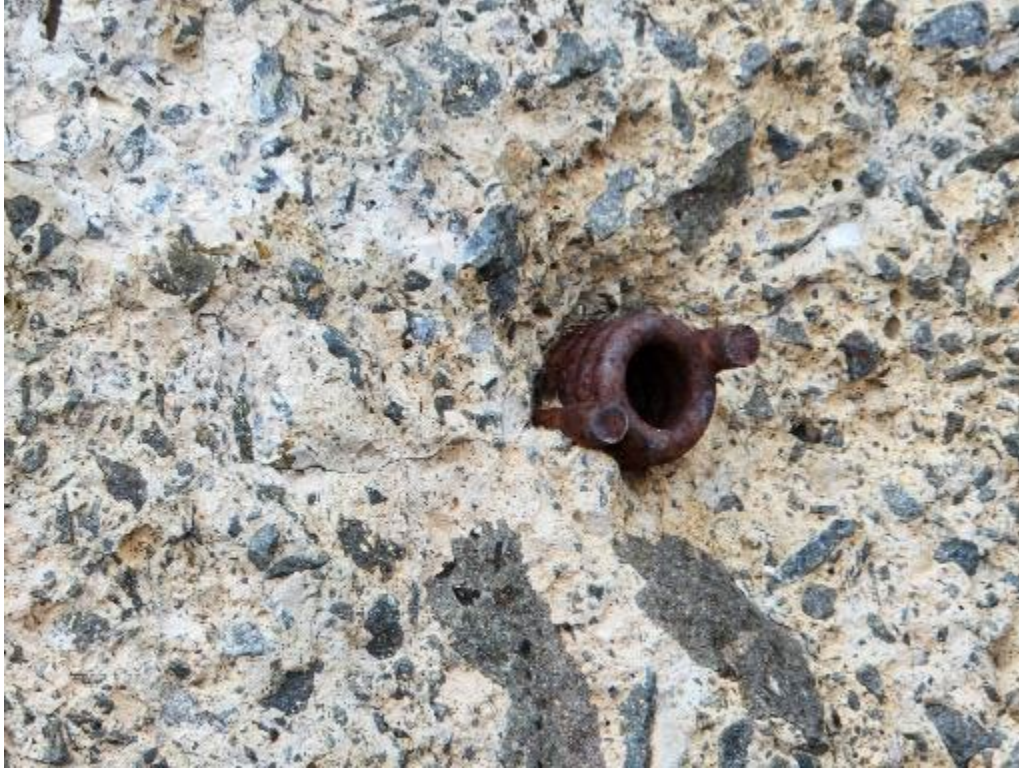
**Photo 18: Exposed and rusted form support insert on spillway surface**

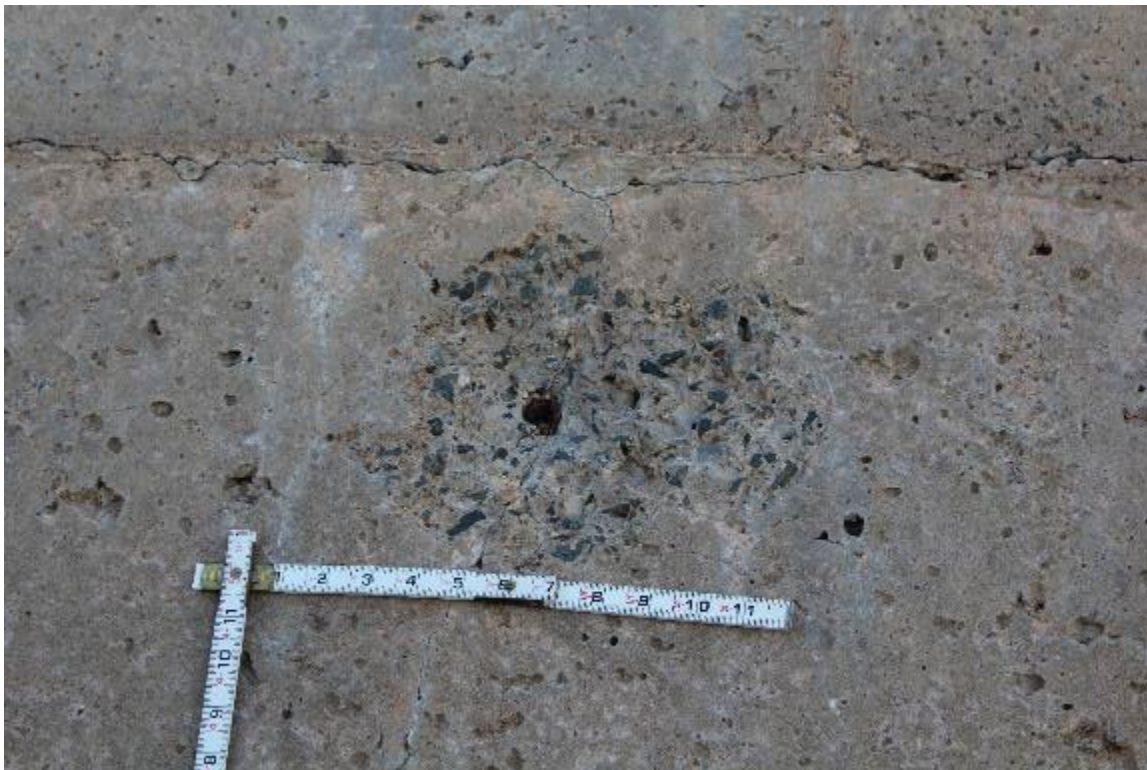
**Photo 19: Spalling at embedded form insert on spillway**

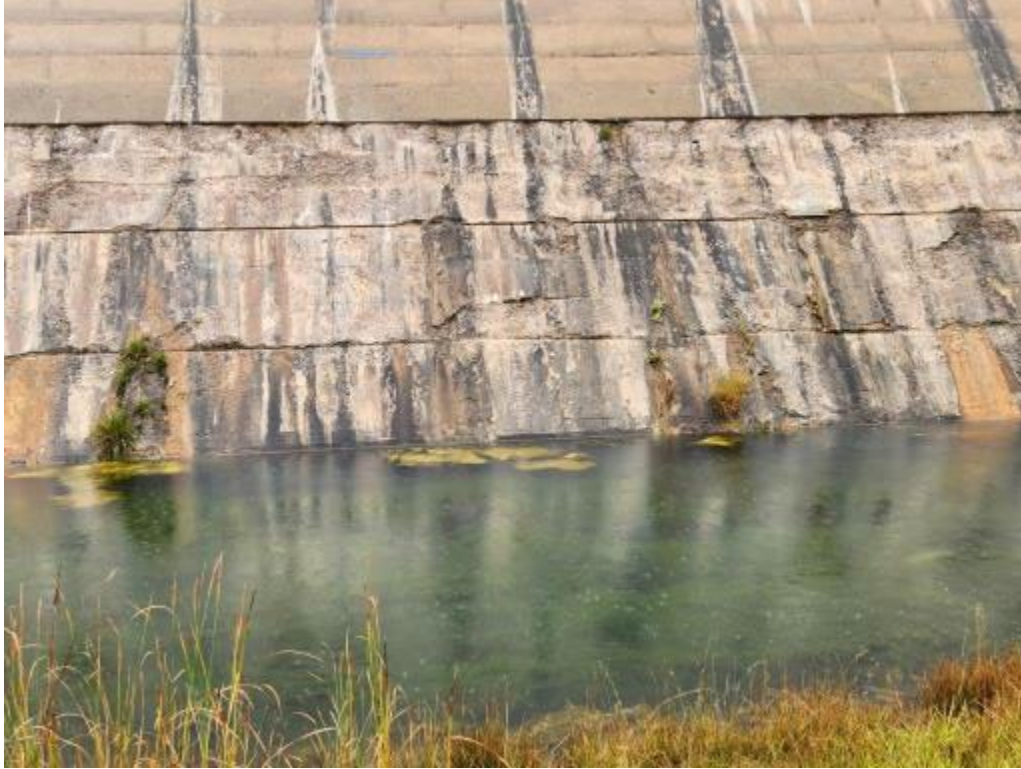
**Photo 20: Deteriorated facing panels on bottom of spillway**

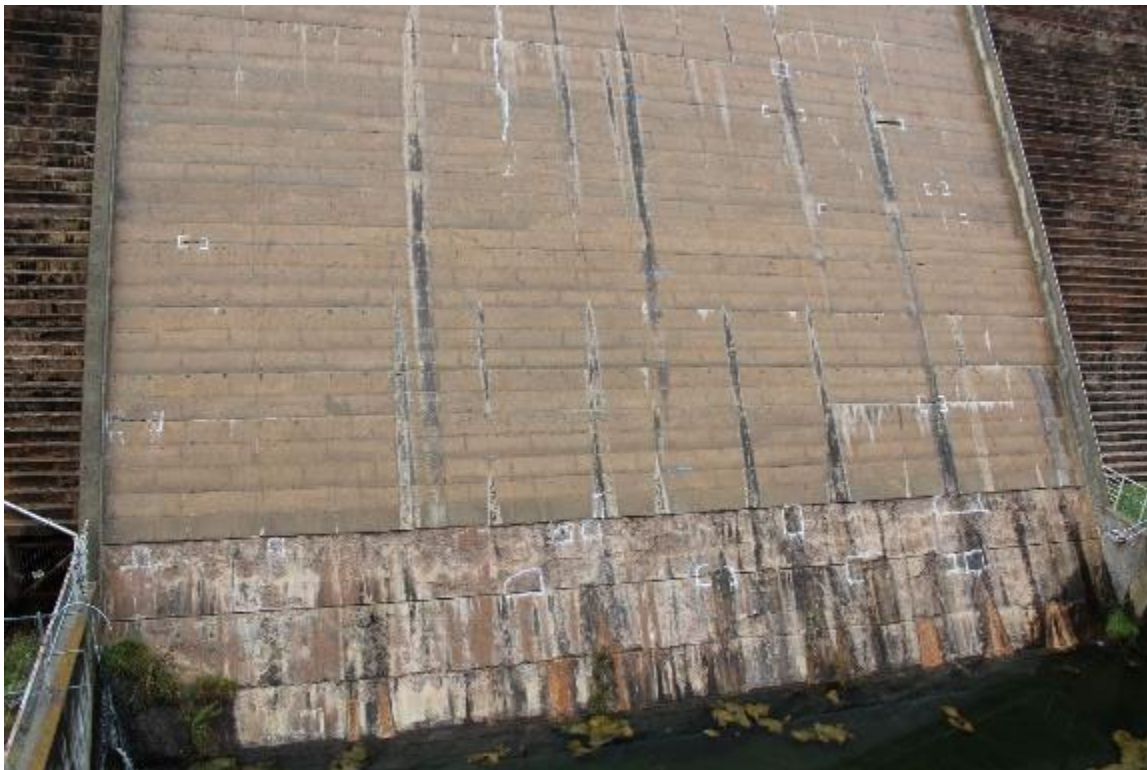
**Photo 21: Deteriorated and delaminated areas on spillway lower facing elements**

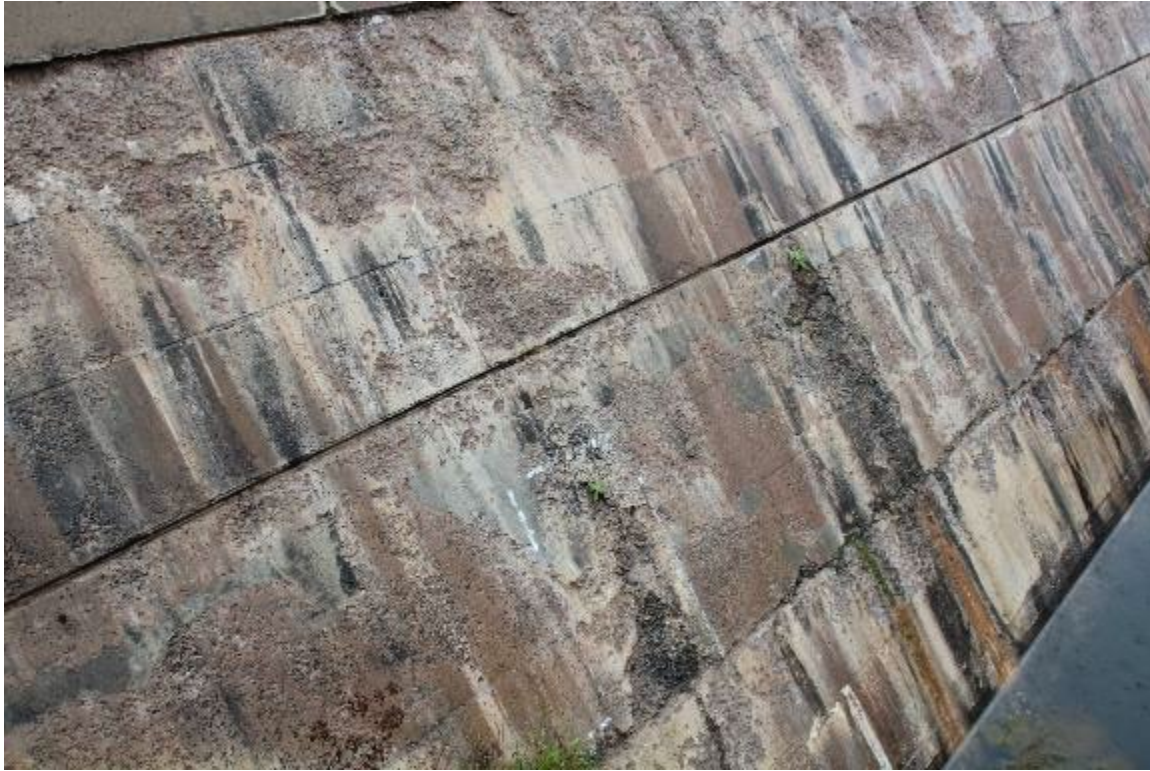
**Photo 22: Deteriorated facing elements at bottom of spillway (note horizontal form lines)**
