**Ref: ITB #2023-017B GRINDSTONE CANYON DAM CONCRETE REPAIR  
PRINCIPAL SPILLWAY AND NORTH DAM CREST**

**ADDENDUM #2**

**Subject: Grindstone Canyon Dam (OSE Filing No. D-513) Spillway and North Dam Crest  
Condition Assessment Report, Village of Ruidoso, New Mexico**

# **GRINDSTONE CANYON DAM (D-513) SPILLWAY AND NORTH DAM CREST CONDITION ASSESSMENT REPORT**

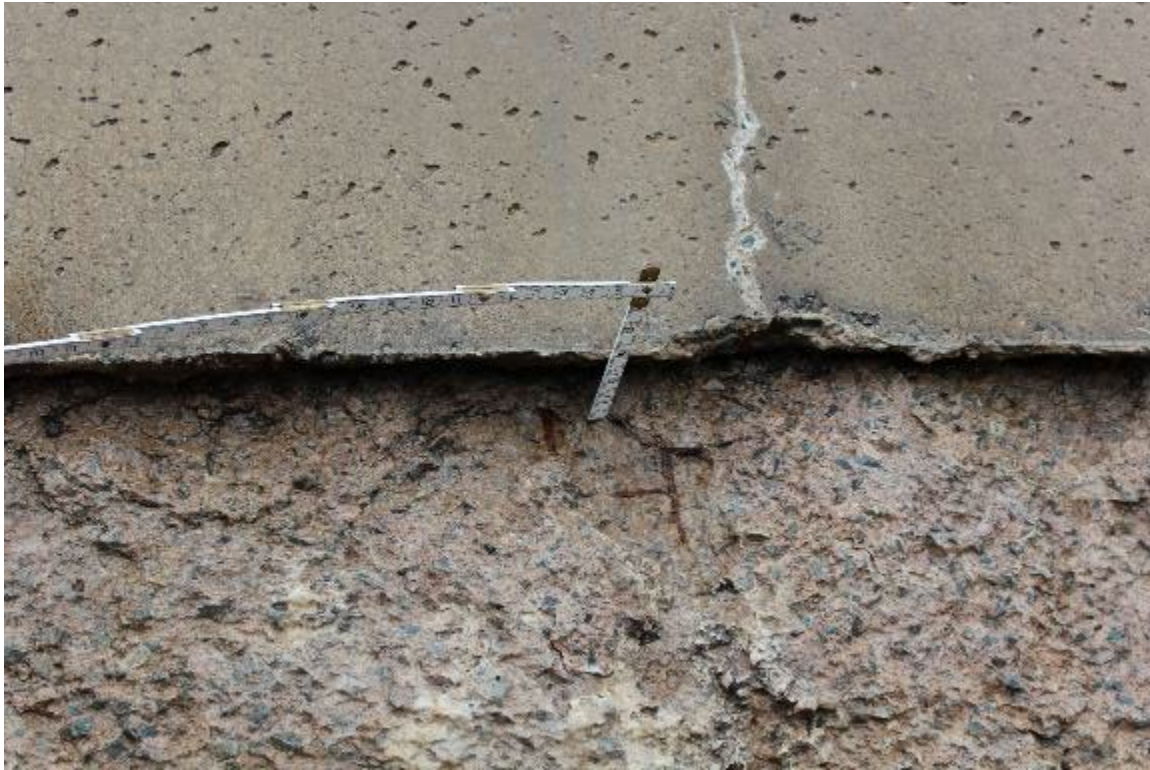
Drummy concrete detected by the rotary hammer and geologist hammer soundings indicated shallow delamination along several areas on the spillway crest. Areas of drummy concrete also were detected on the spillway face between the bottom of the mass concrete crest and the bottom of the spillway, where there is a concentration of drummy concrete and evidence of extensive freeze-thaw damage on the facing elements. This freeze-thaw damage was likely due to the extensive seepage that occurred in this area of the spillway immediately following filling of the reservoir and before any seepage mitigation work was completed. The erosion of concrete damaged by freeze-thaw has resulted in an eroded surface up to approximately 4 inches below the adjacent, undamaged spillway surface (see Photo 23).

**Photo 23: Depth of erosion at top of third facing element above bottom of spillway**

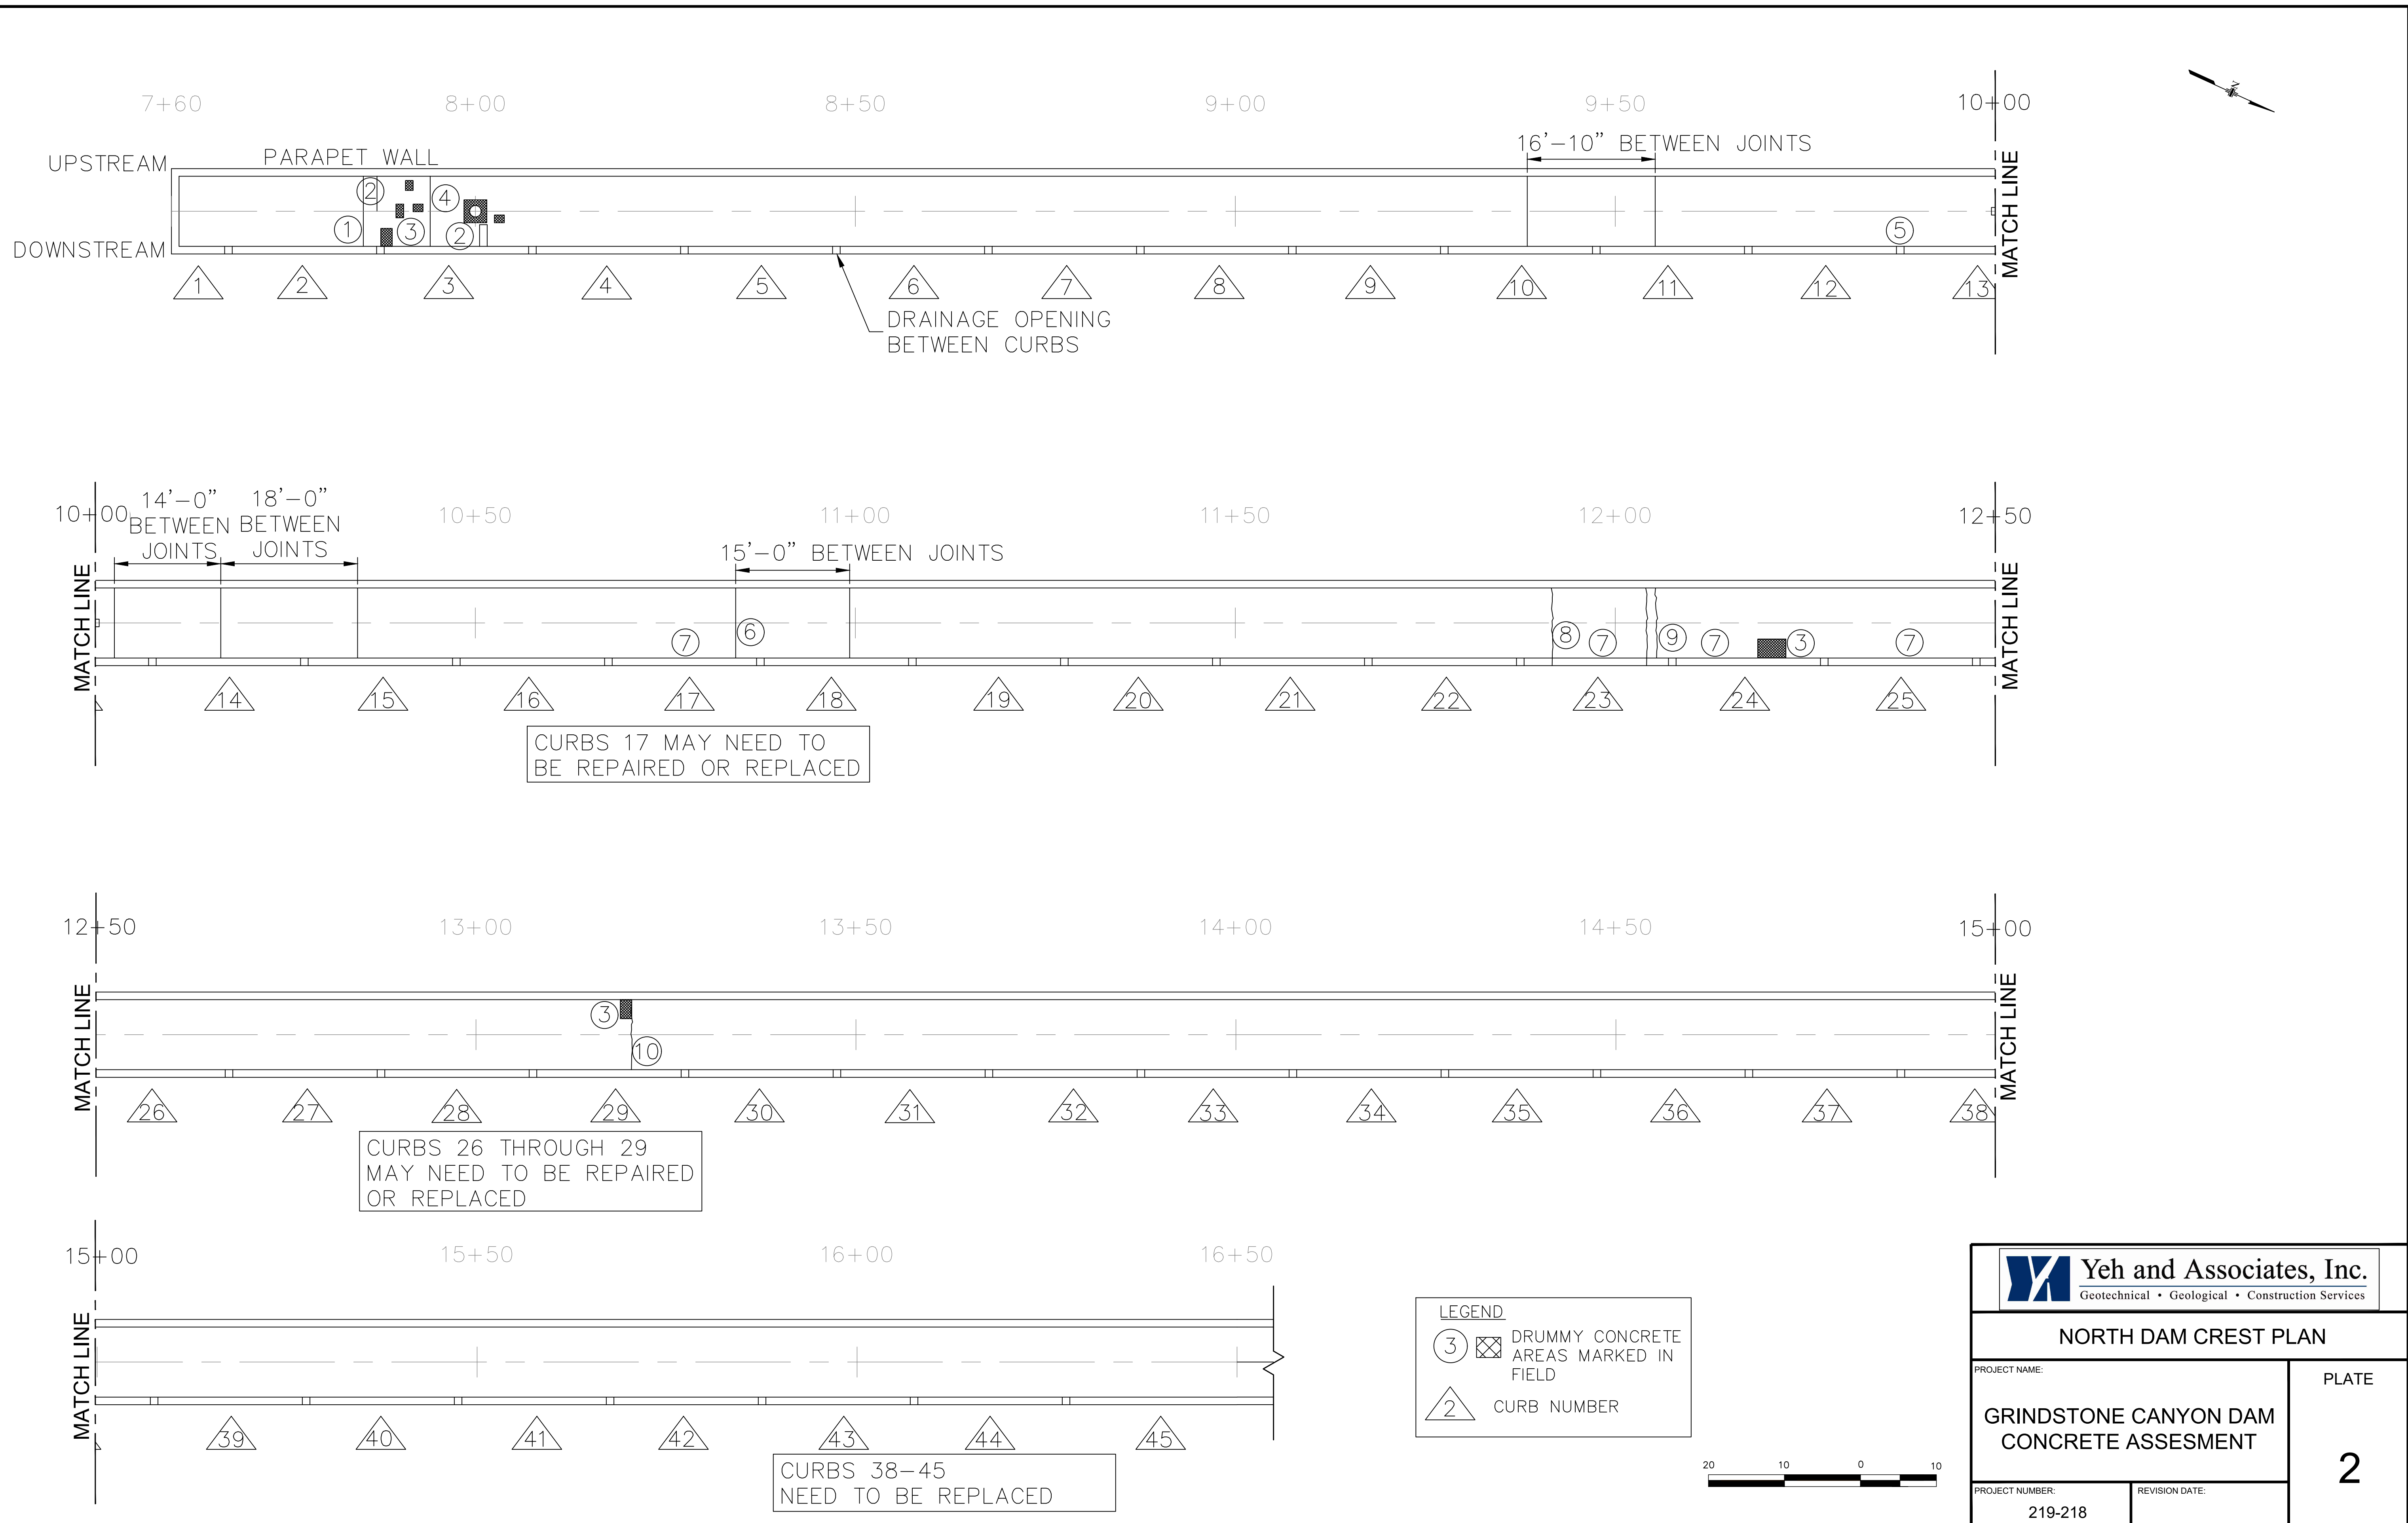
1. Transition from good concrete to deteriorated concrete; deteriorated surface up to ½” below apparent original surface
2. Rusted rebar exposed at surface; spaced at 10”; ½” below original surface

3. Some drummy concrete areas marked in field; need repair
4. Horizontal transverse joint in deteriorated concrete; typical spacing 16’ (aligned w/ joints on downstream face); exceptions to typical spacing are noted on the drawing

5. Exposed rebar on curbs 12 and 13; exposed rebar between most curbs
6. Transition from deteriorated concrete to good concrete; drummy concrete areas randomly located throughout deteriorated concrete area

7. Southern most curb in need of repair (curb 17), also repair or replace curbs 23, 24, 25, 27, 28, and 29; repair could replace 8” height, 3” width, 19’ length.

8. Crack in concrete; up to 6” long, up to ½” wide; crack persists through curb.
9. Crack in concrete; up to 24” long; less than 1/8” wide.
10. Crack in concrete up to 1/2” long; up to ¼” wide; previously sealed.

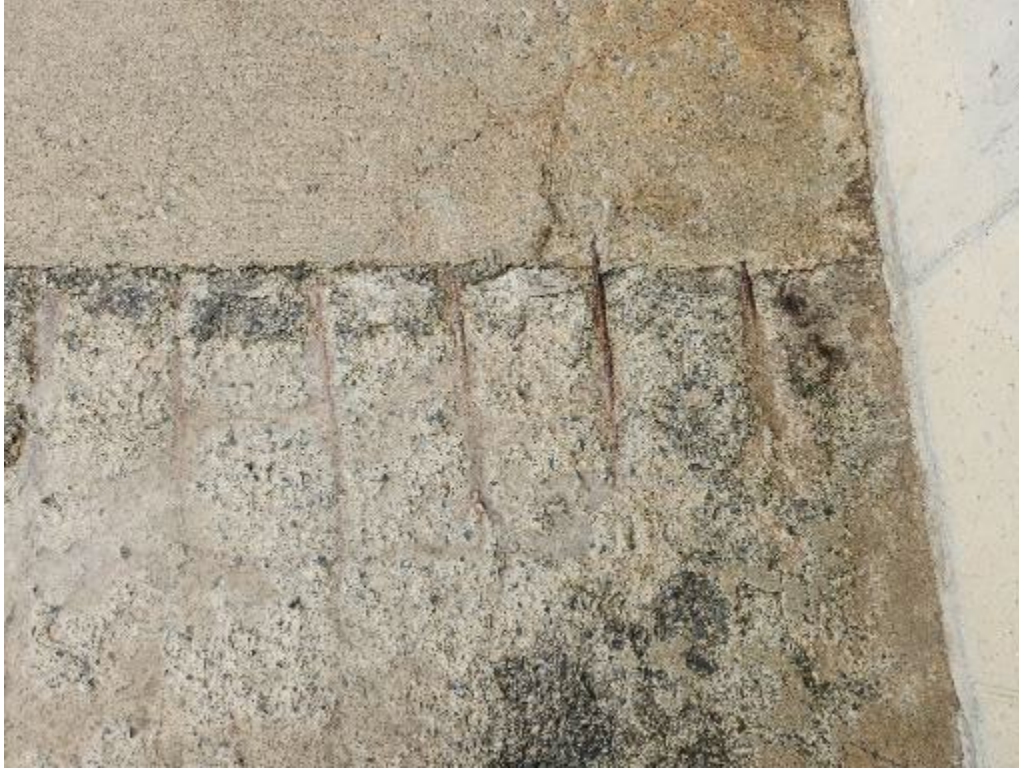
Six rusted reinforcing bars about 18 inches long, spaced 10 inches on centers, were observed at the surface at Station 7+84. This reinforcement is not shown on any of the drawings provided by the VOR or NMOSE. The purpose, exact length and number of reinforcing bars are unknown. There is another small group of similar reinforcing bars embedded in the surface a short distance north of Station 7+84. These reinforcing bars will need to be removed to replace the deteriorated concrete on the dam crest.

**Photo 24: Rebar embedded at surface on south end of north dam crest**

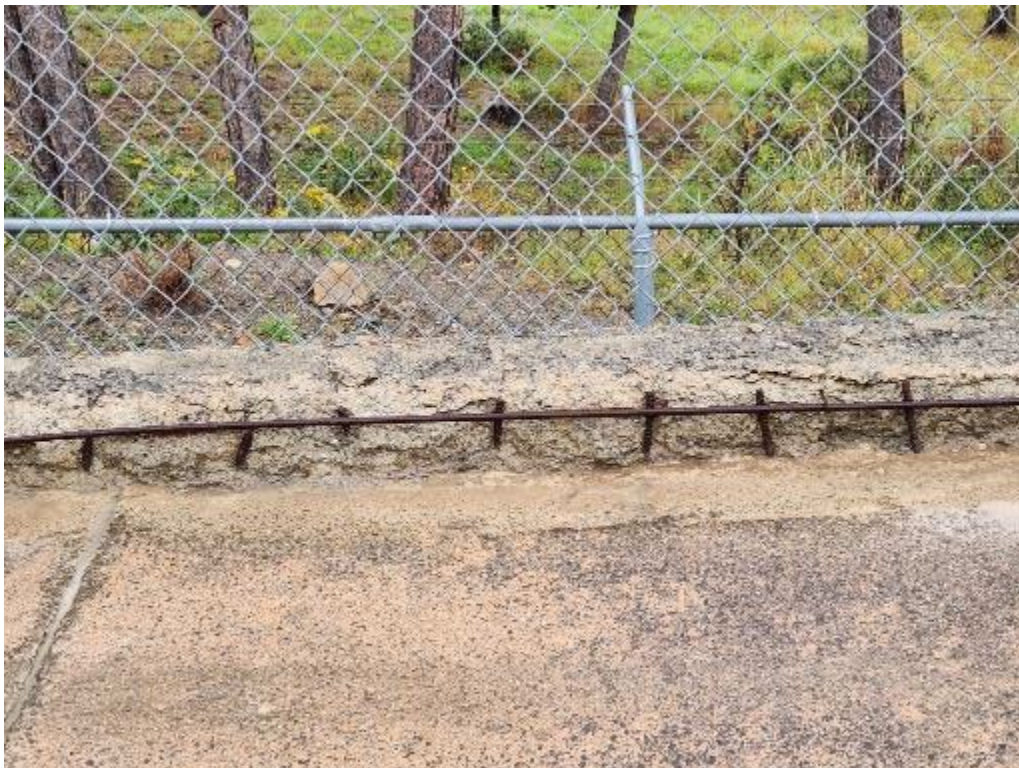
**Photo 25: Deteriorated curb and exposed rebar on dam crest**

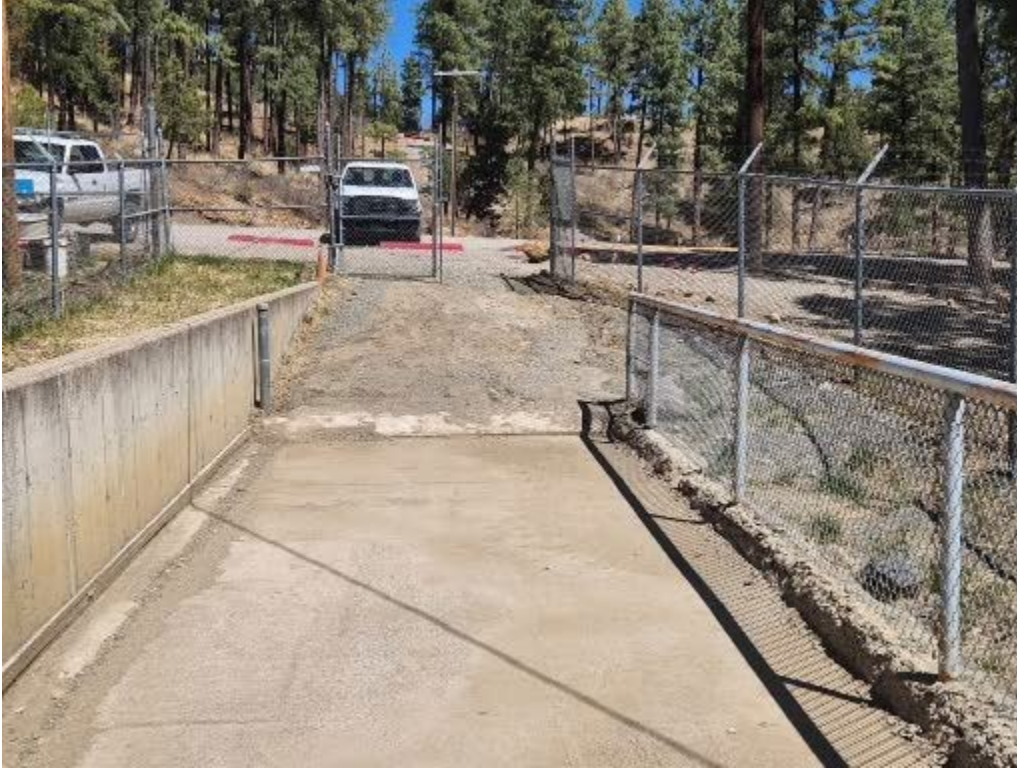
**Photo 26: Severely deteriorated curbs at north end of north dam crest**

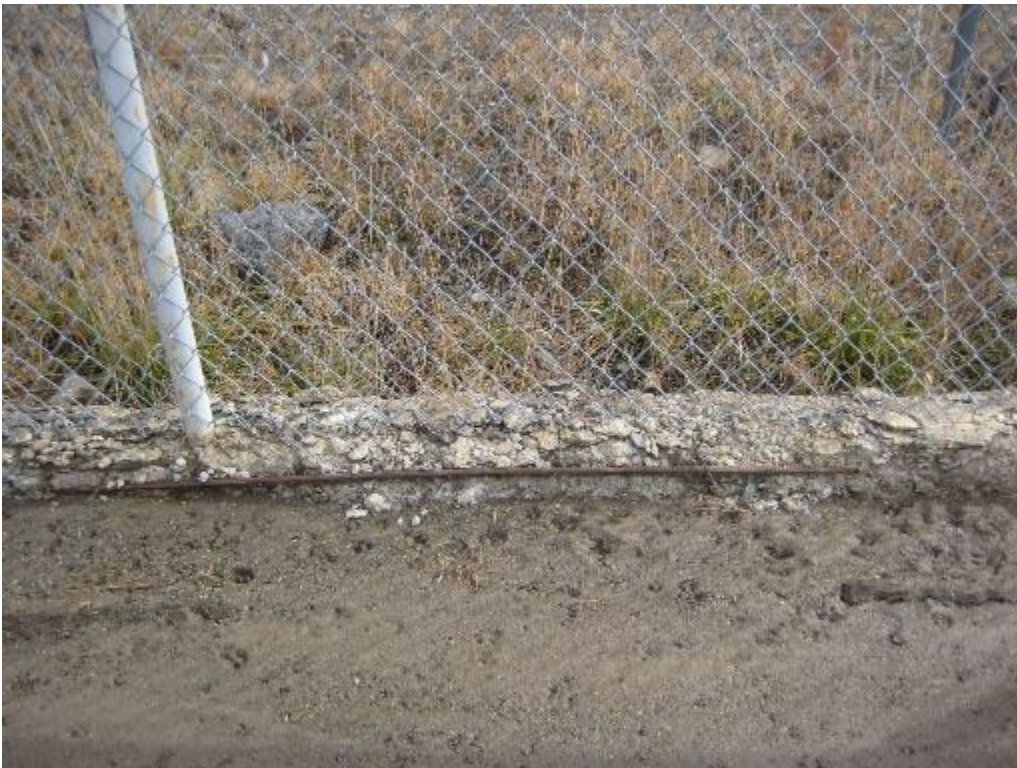
**Photo 27: Deteriorated curb on north end of north dam crest**

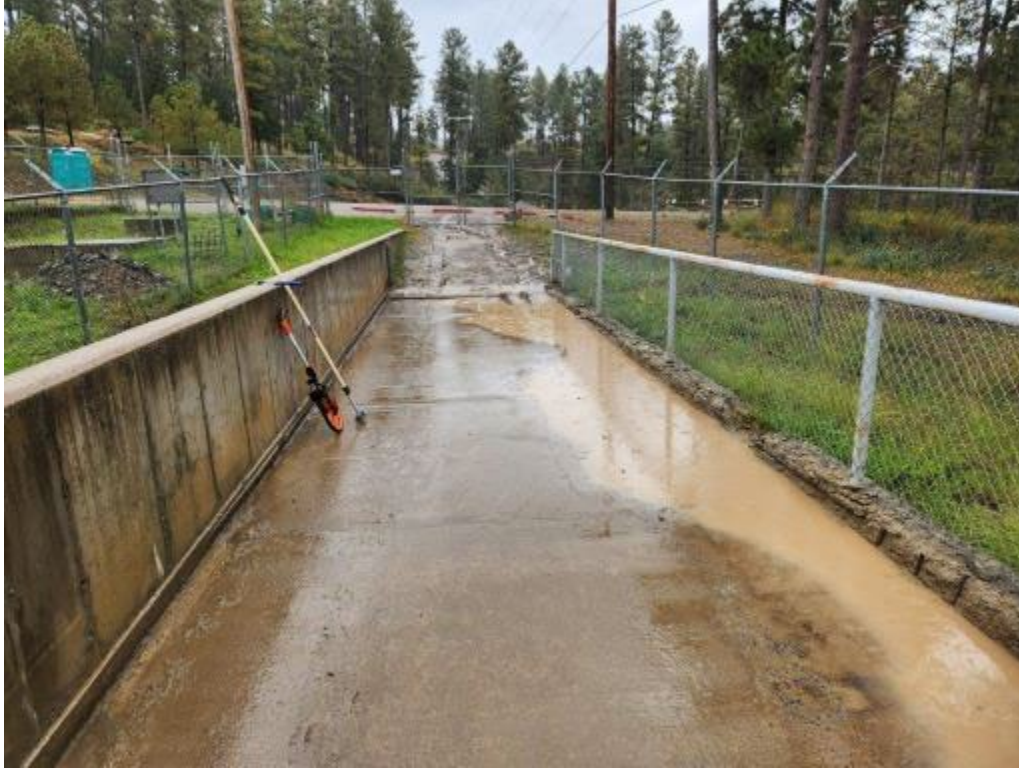
**Photo 28: Severely deteriorated curbs and ponding on north end of north dam crest**

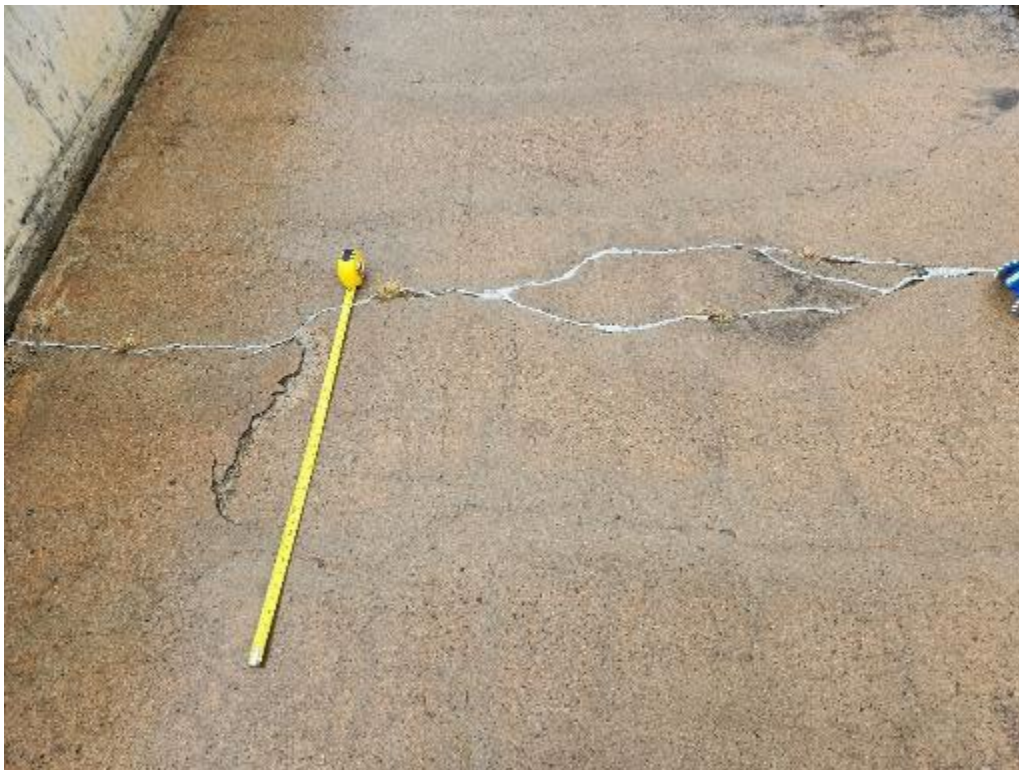
Transverse cracking and small areas of drummy concrete and delamination were observed in the dam crest at Stations 11+92, 12+10 and 13+22. The crack at Station 13+22 was previously caulked with sealant.

**Photo 29: Delamination and cracking on dam crest, note previous caulking of crack with sealant**

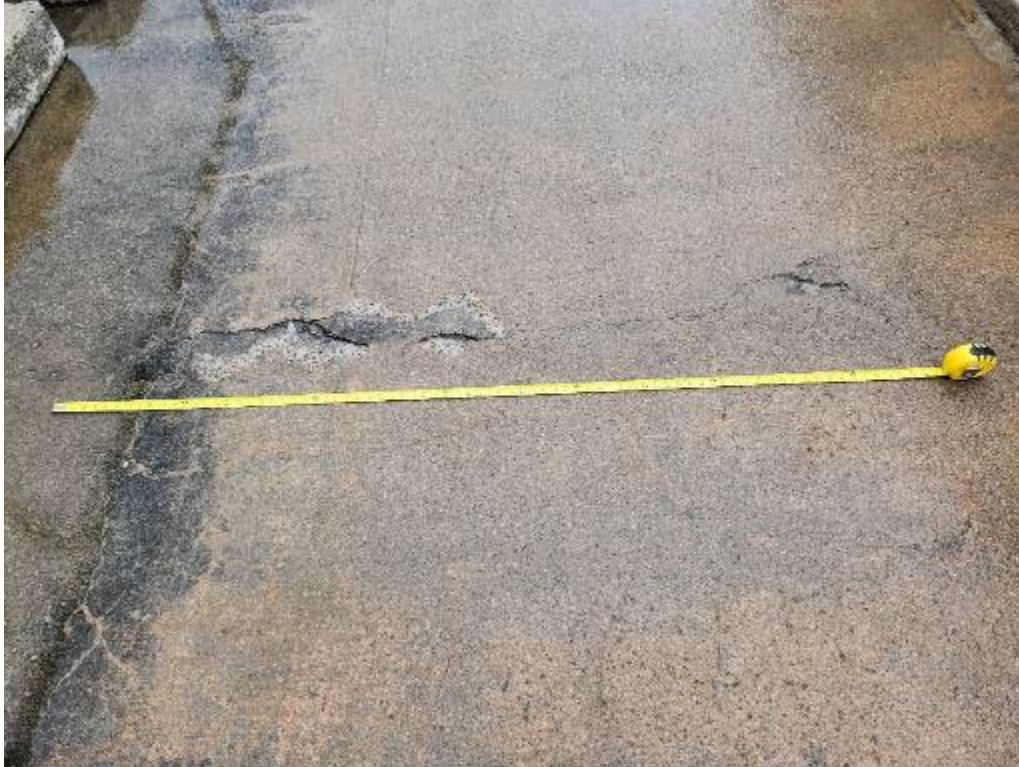
**Photo 30: Delamination and cracking on dam crest**

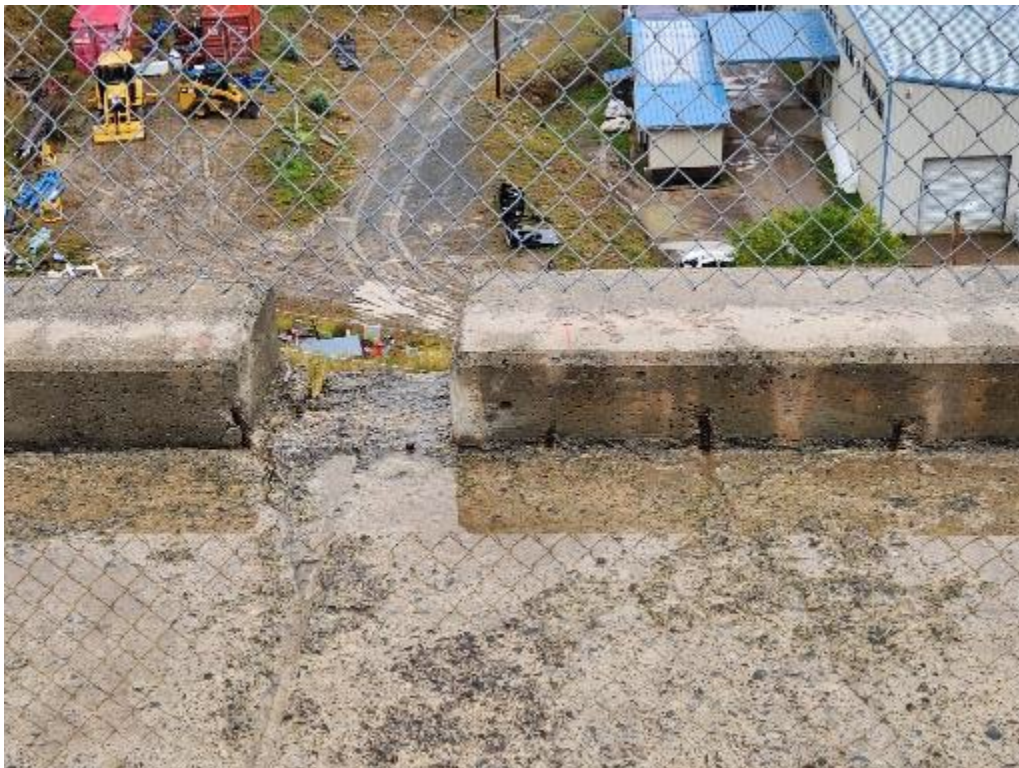
**Photo 31: Exposed rebar along side of curb on dam crest**

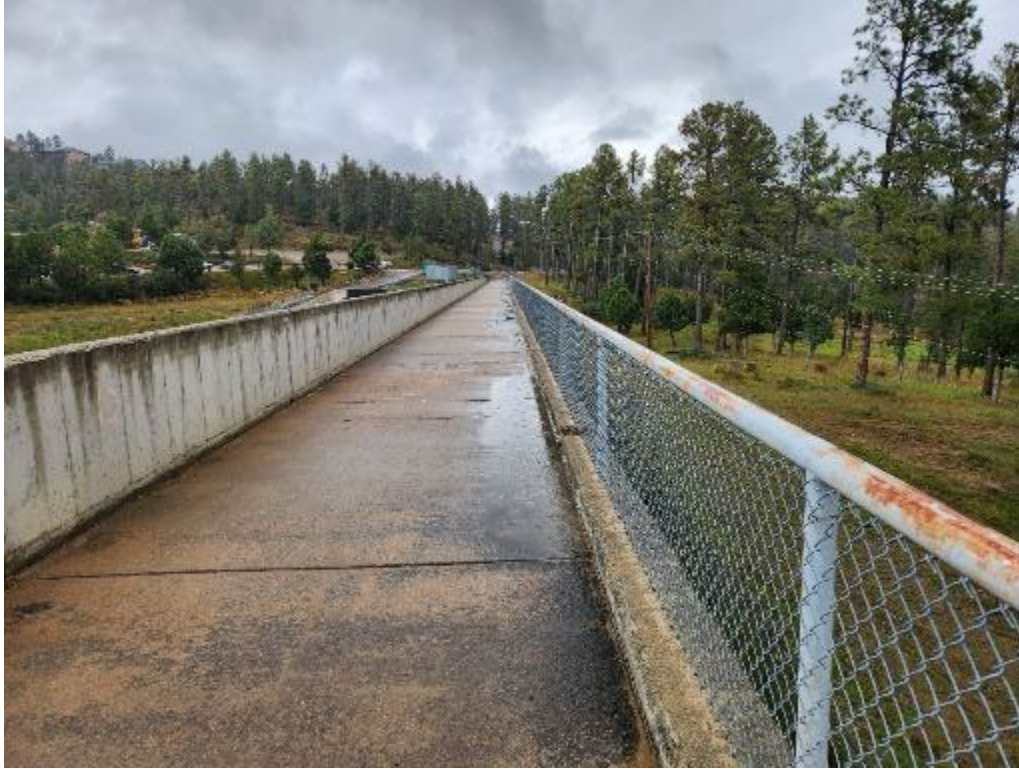
Ponding was observed against the curbs over the entire length of the north dam crest and may contribute to some of the deterioration and delamination.

**Photo 32: Ponding at curbs on dam crest**

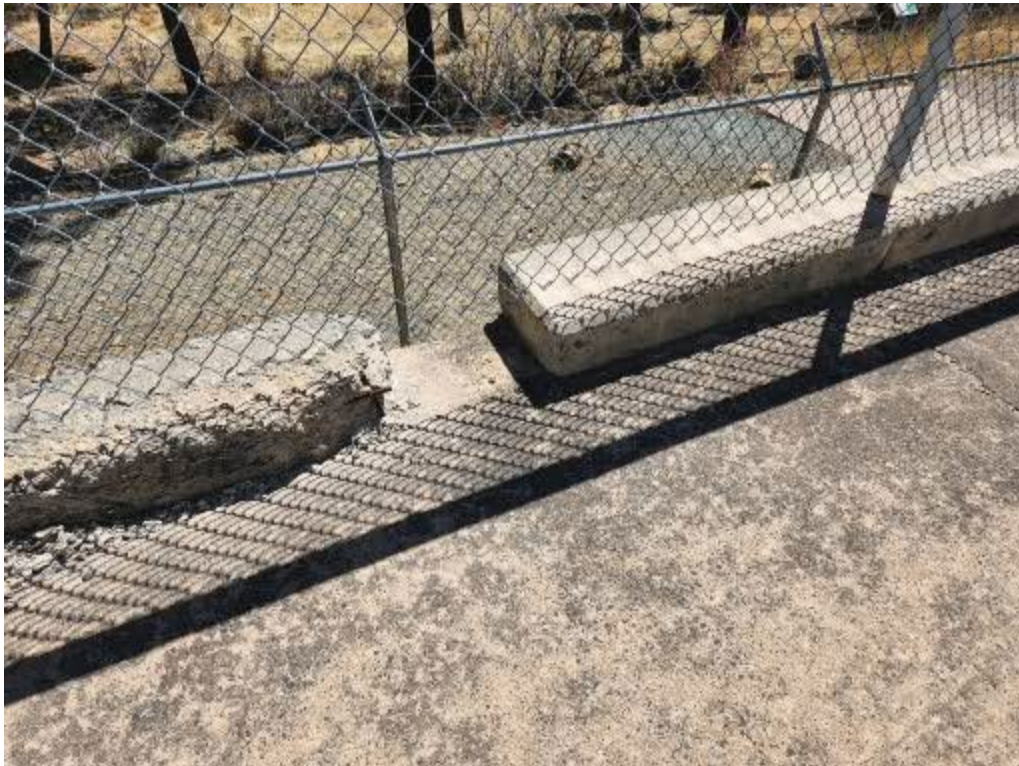
**Photo 33: Change from severely deteriorated curb to non-deteriorated curb on dam crest**

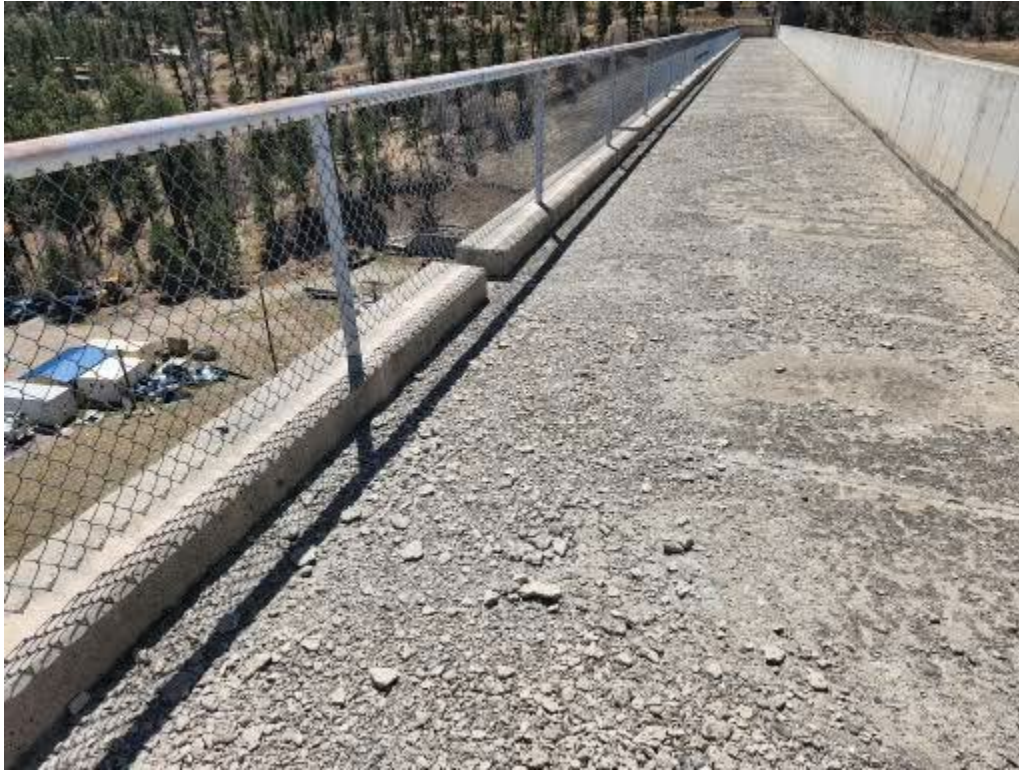
**Photo 34: Deteriorated concrete surface on dam crest**

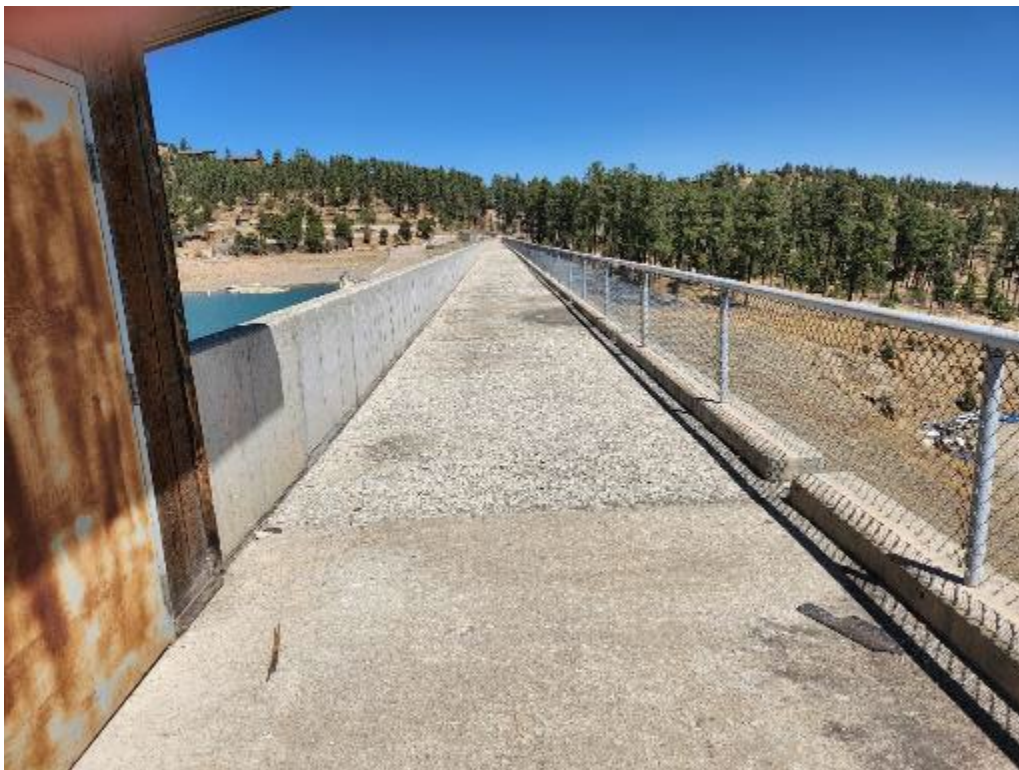
**Photo 35: Transition from good to deteriorated concrete at south end of north dam crest**

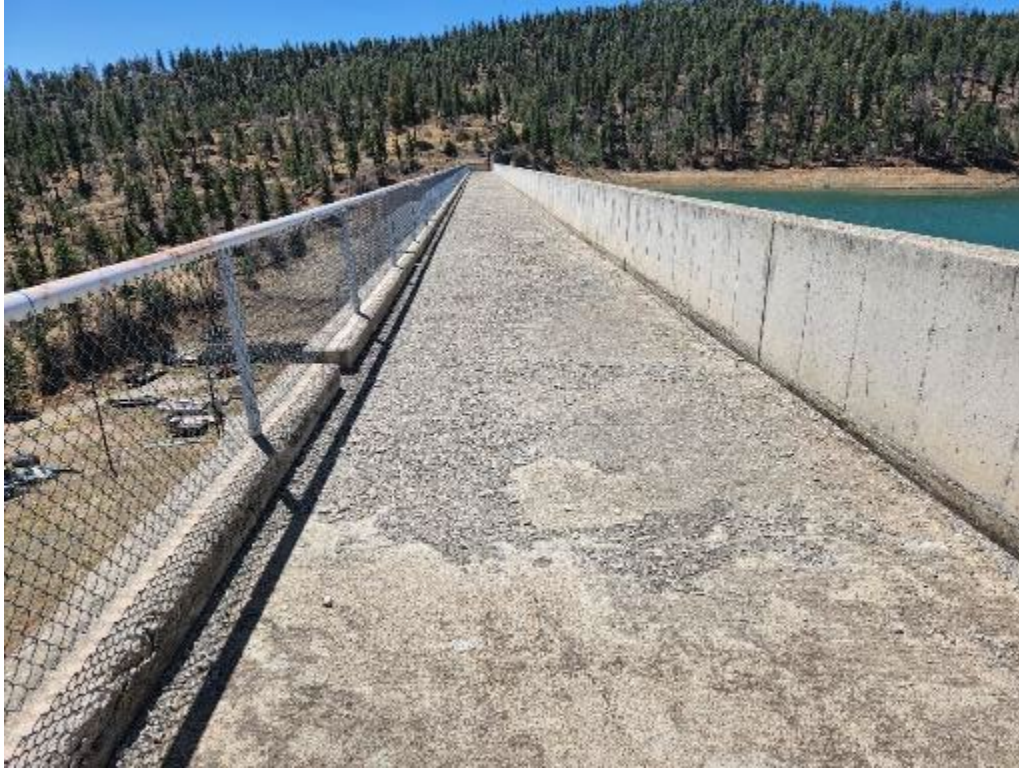
**Photo 36: Transition from deteriorated concrete to good concrete on the dam crest.**
