**Ref: ITB #2023-017B GRINDSTONE CANYON DAM CONCRETE REPAIR  
PRINCIPAL SPILLWAY AND NORTH DAM CREST**

**ADDENDUM #2**

**Subject: Grindstone Canyon Dam (OSE Filing No. D-513) Spillway and North Dam Crest  
Condition Assessment Report, Village of Ruidoso, New Mexico**

# **GRINDSTONE CANYON DAM (D-513) SPILLWAY AND NORTH DAM CREST CONDITION ASSESSMENT REPORT**

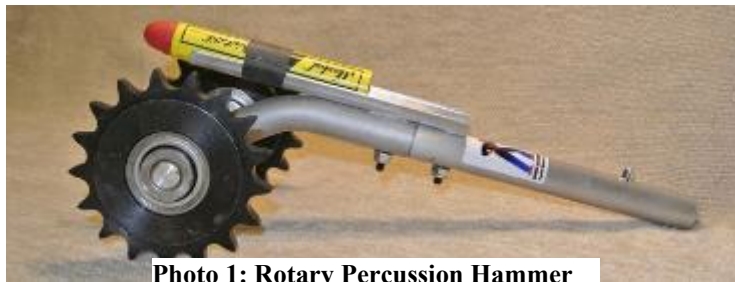
**Photo 1: Rotary Percussion Hammer**

A rotary percussion hammer sounding survey was performed over the surface of the emergency spillway chute and crest. . The rotary percussion hammer used for the delamination survey is shown in Photo 1.

Yeh and Hutton performed the non-destructive rotary percussion hammer sounding according to ASTM D 4580-12 Standard Practice for Measuring Delaminations in Concrete by Sounding - Procedure C – Rotary Percussion. The rotary hammer included a 10-foot aluminum tube extension. An additional 10-foot aluminum extension was purchased and added to the rotary hammer to extend the reach from the man-basket. The additional extension magnified the sound from the rotary hammer.
